SOUTHEASTERN WISCONSIN REGIONAL PLANNING COMMISSION

MEMORANDUM

SUBJECT: SOUTHEAST WISCONSIN 2015 LIDAR (SEWI_5)

Washington County LiDAR Review

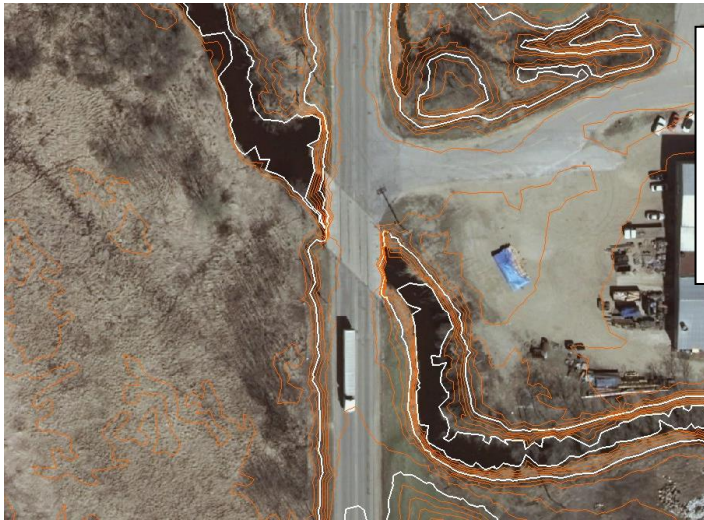
- Numerous bridges were improperly classified (still consider ground) which also affects DTM and Contours – Samples documenting the misclassification are evident throughout the County – reedit of Classified LAS files, contour regeneration, and new DTM files would be necessary to correct this issue.
- Numerous bridges were improperly classified (Class 1) instead of contracted Class 14 – reedit of Classified LAS files would be necessary, however, contour regeneration, and new DTM files are not necessary in correcting this issue.
- Below are samples of ground points on top of bridge sites and misclassified bridges. Each sample has an XY location and comments to understand the edit call.

XY Location:
Northing: 488900
Easting: 2422800
Comment: Bridge classified using Classes 1 and 17 (Non-Ground and Overlap Non-Ground)...should be Class 14 (Bridge)

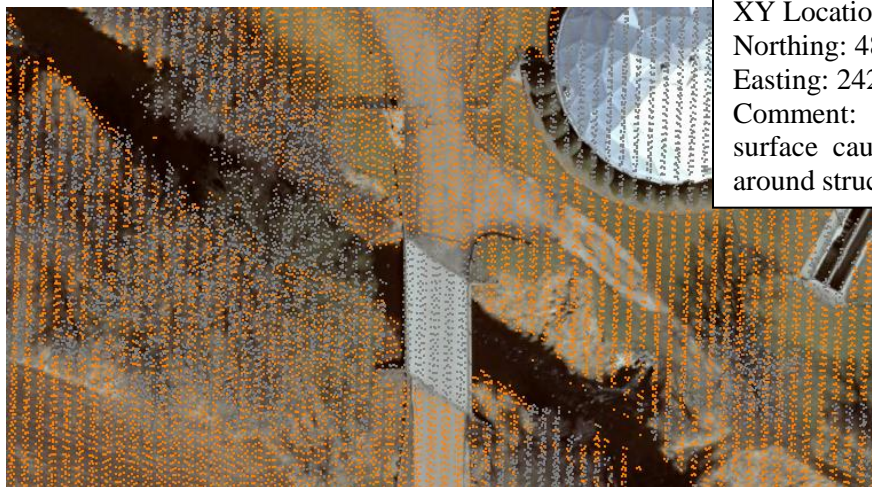
XY Location:
Northing: 485500
Easting: 2428440
Comment: Ground points left in surface causing improper contouring around structure.

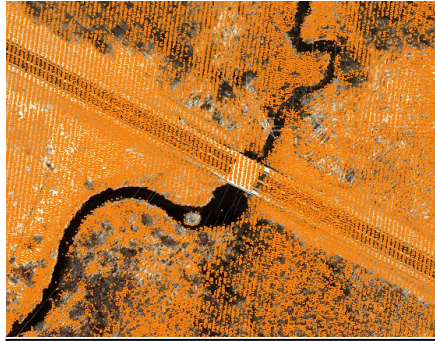
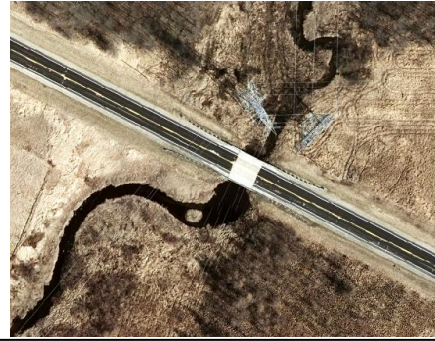
XY Location:
Northing: 502300
Easting: 2513200
Comment: Ground points left in surface causing improper contouring around structure.

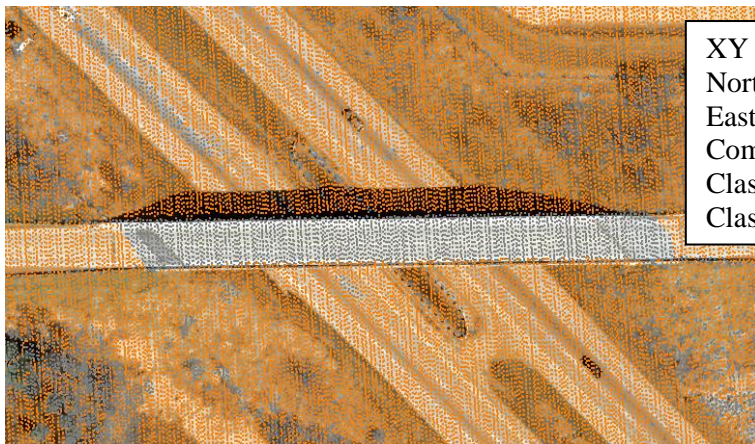
XY Location:
Northing: 477200
Easting: 2476400
Comment: Bridge classified using Class 1 (Non-Ground)...should be Class 14 (Bridge)

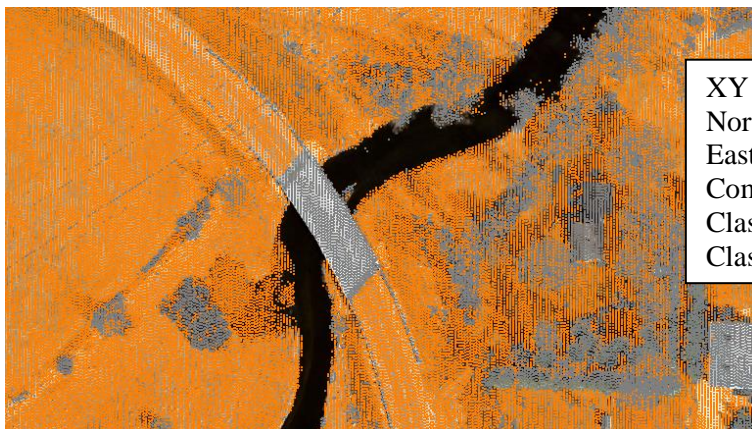
XY Location:
Northing: 495900
Easting: 2511300
Comment: Bridge classified using Class 1 (Non-Ground)...should be Class 14 (Bridge)

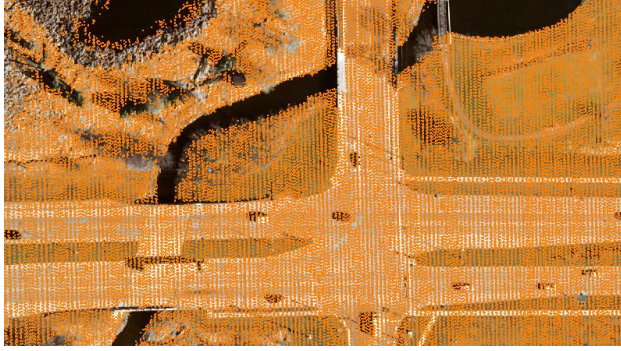
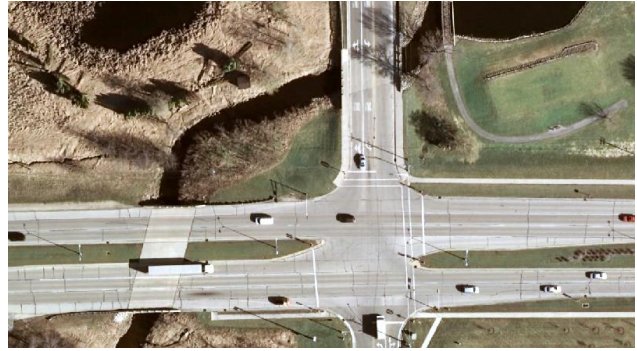
XY Location: Northing: 450600; Easting: 2497600
 Comment: Ground points left in surface causing improper contouring around structure.

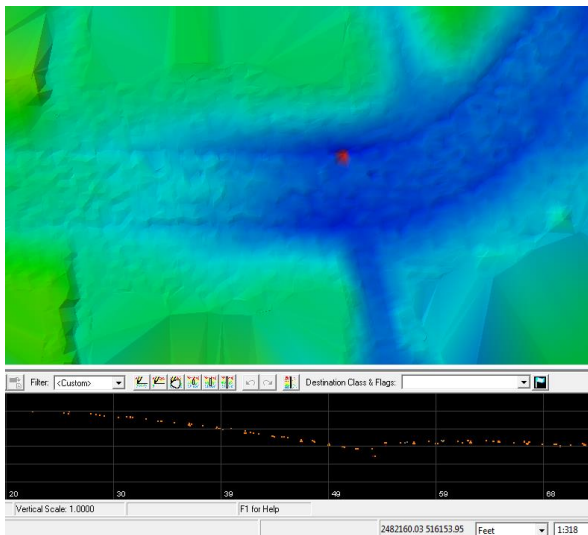
- Minor edits are also evident throughout the project area with low points (point in storm sewers) that affect the surface accuracy of roads. In addition found a lone Model Keypoint in a water surface. Editing team should correct these errors and make a review of the ground surface for other minor imperfections when fixing the bridges. Sample of these minor issues is below along with the XY location

XY Location:
 Northing: 516154
 Easting: 2482167
 Comment: Ground points in storm sewer affecting the road elevation. Also model keypoint has a point in the storm sewer that would also affect the surface elevation

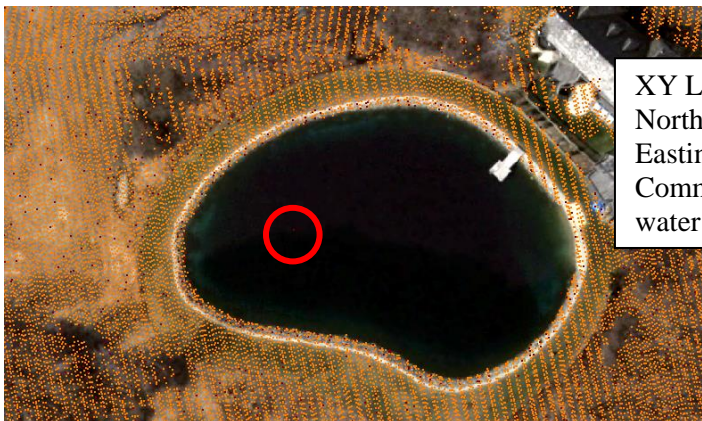
XY Location:
 Northing: 511425
 Easting: 2470591
 Comment: Single Model keypoint in water body.

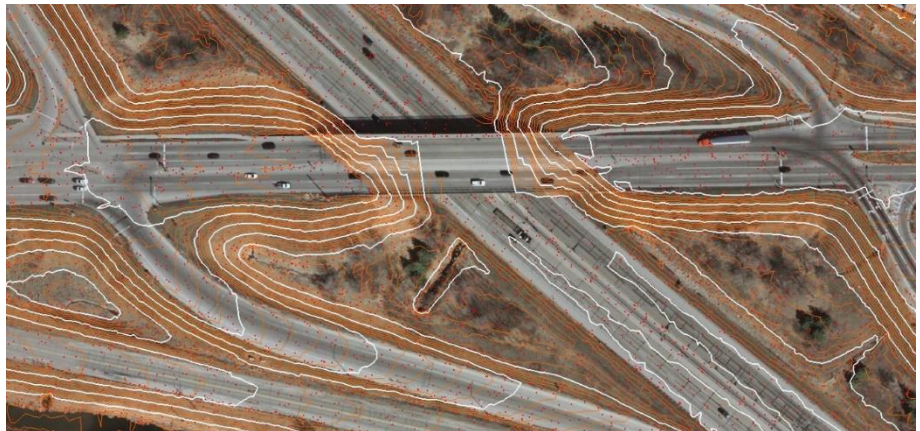
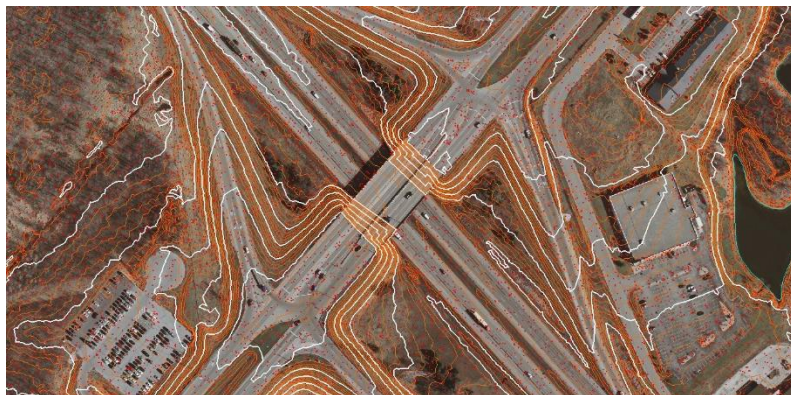
- Data delivered in wrong format
- Data provided on wrong datum
- Bridge Contouring issues – need breakline along each side to enforce the triangulation down to the road and/or water surface. See samples below on erratic contouring along removed bridge points.

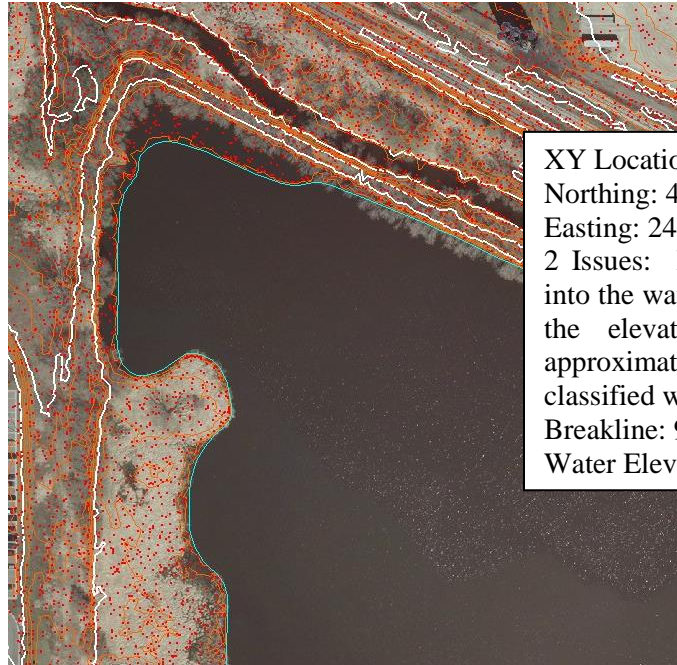
XY Location:
 Northing: 487400
 Easting: 2426200
 2 Issues: Hydro breakline encroaches into the water body significantly. Also, the elevation of the breakline is approximately 1.5 feet lower than the classified water points.
 Breakline: 956.000 feet
 Water Elev. approximately 957.5 feet

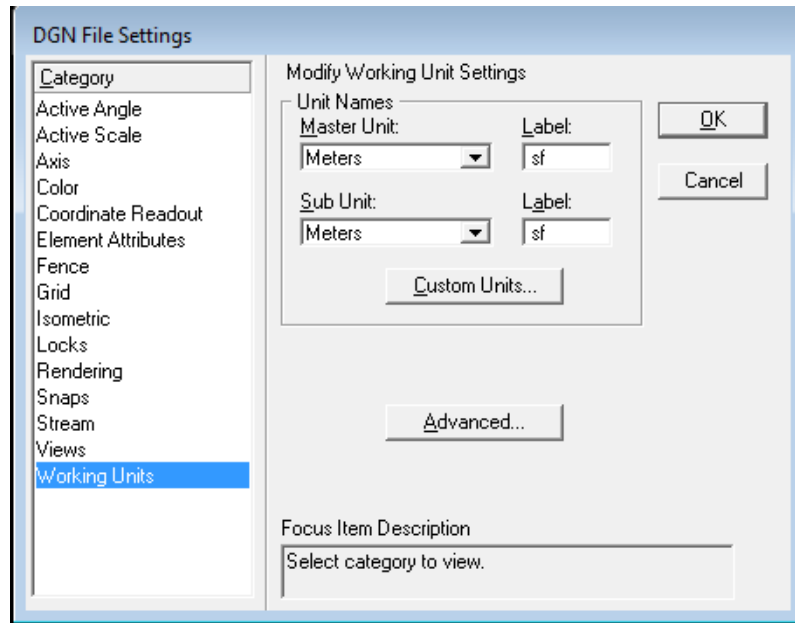
- Data provided in wrong format
- Data also provided on wrong datum
- Quick review comment – Design file had wrong working units assigned. See screen capture below for future reference but is no factor since the data format will change:

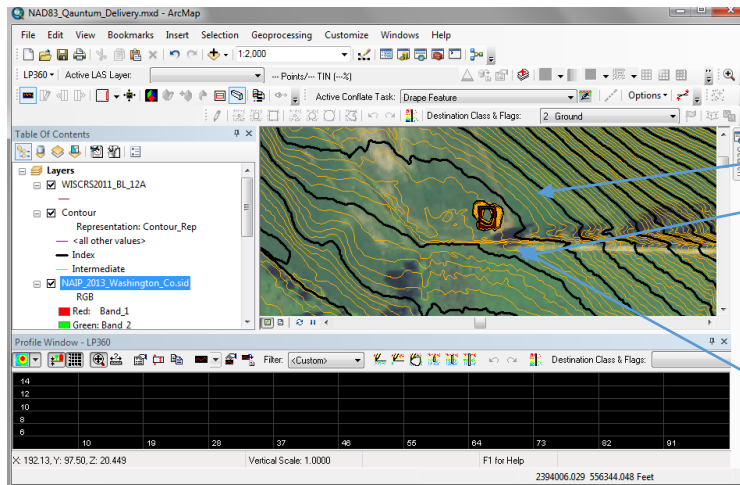
NAD83 Position:
X = 2394009ft; Y=556345ft

- A zero elevation breakline has been included affecting the contour generation which needs to be removed and new contours generated.

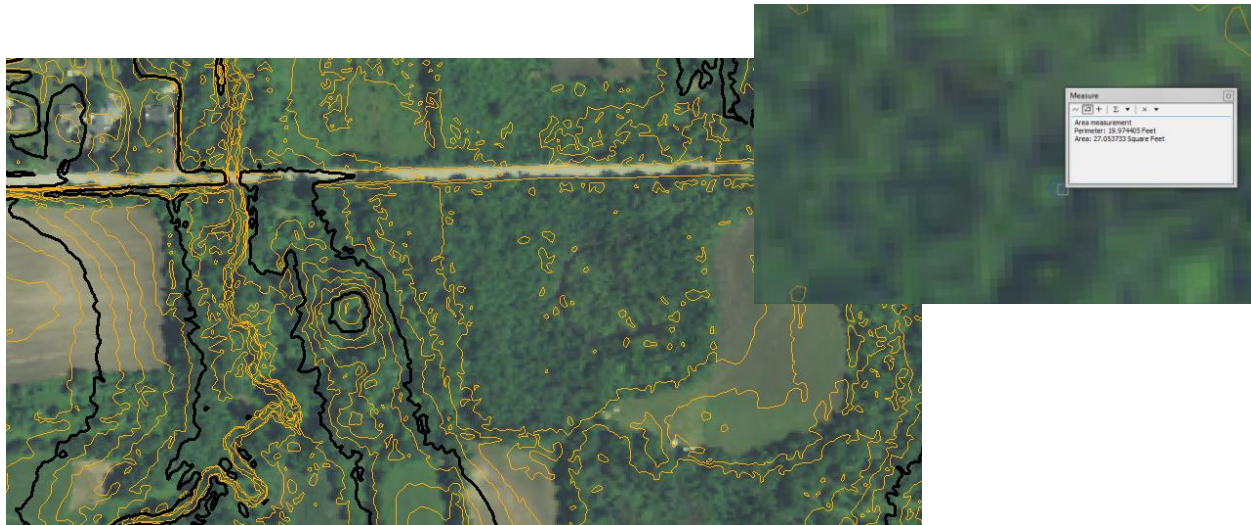
- Contouring filtering with removal of small contours are still evident throughout. Sample below show small contours of 27 ft² are evident. Agreed parameters of tops being 40ft² and depression that are 400ft² were to be filtered out. Regeneration of contours using provided parameters is necessary to remove analogous contours.

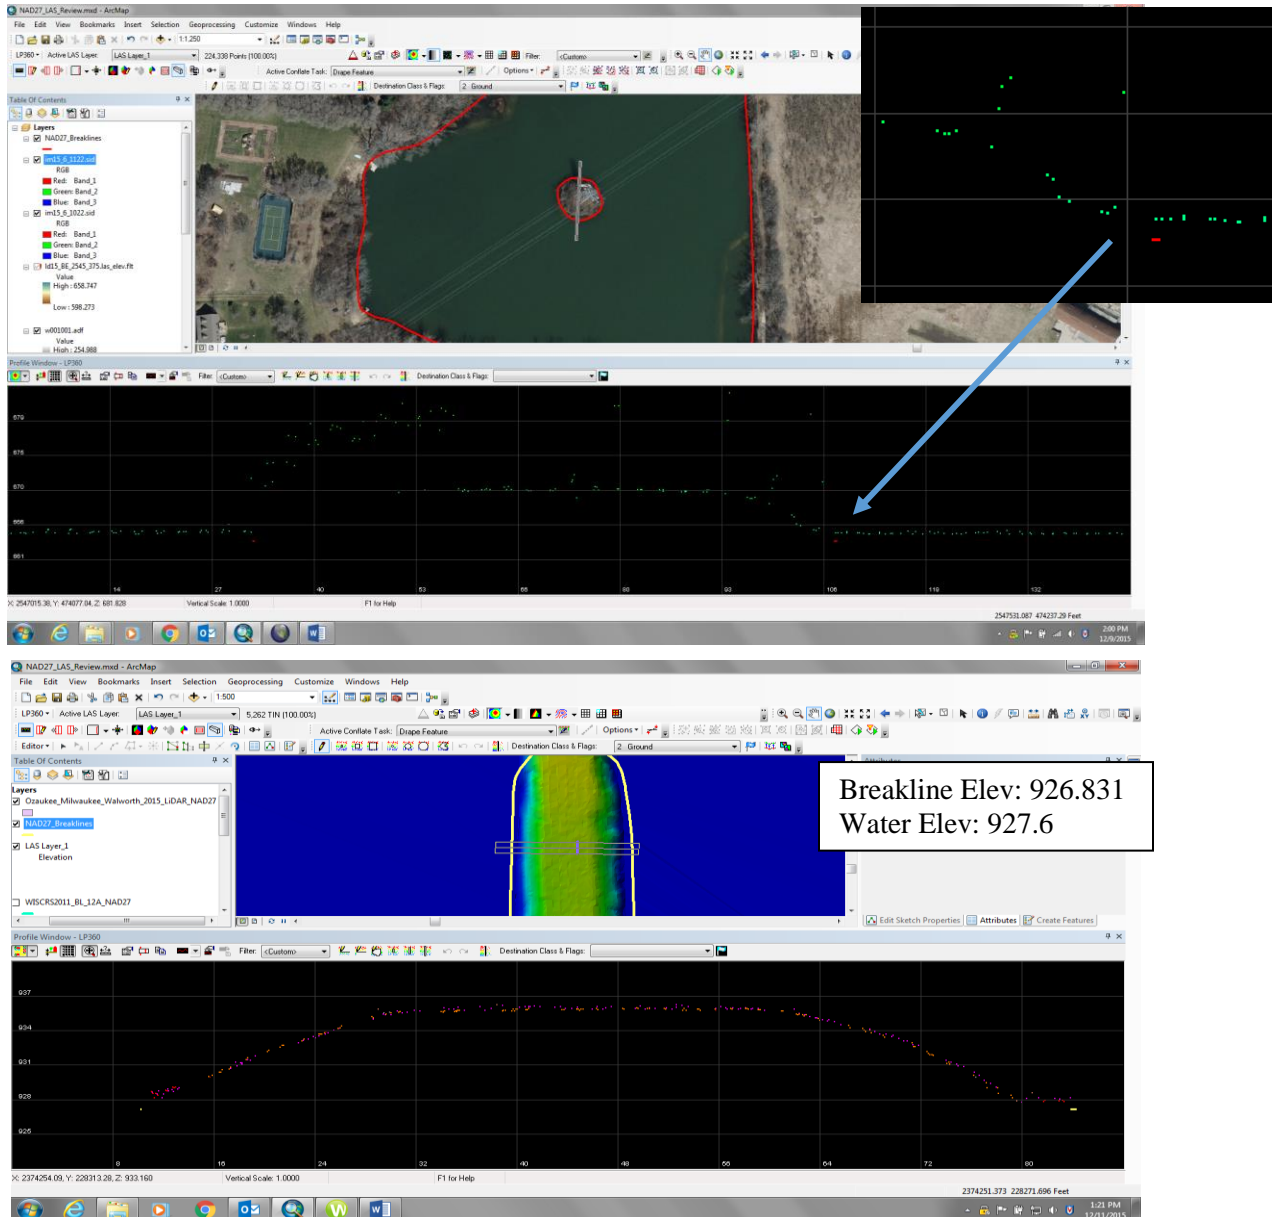
- Overall all hydro breaklines appear to be 0.5 – 1.5 feet lower than expect terrain. See below for screen capture examples demonstrating the inconsistencies. It should be noted that the bridge breaklines are consistent with topology. The hydro breaklines might be a possible indexing related to finalization of the classified LAS files due to Geoid procedures.

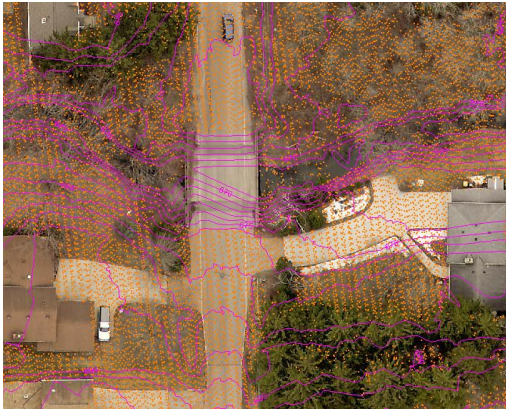
- A few bridge breakline were missed. Below is a screen capture demonstrating the issue when no breakline are used on shorter spans

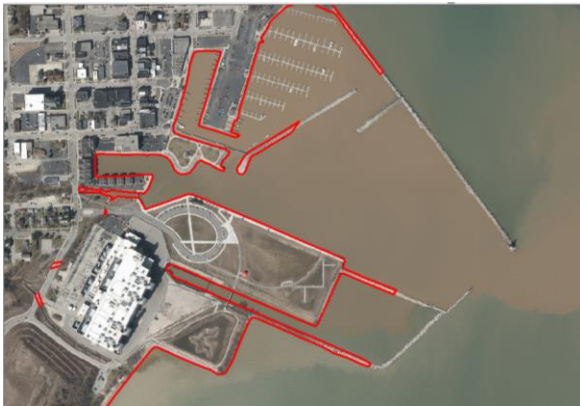
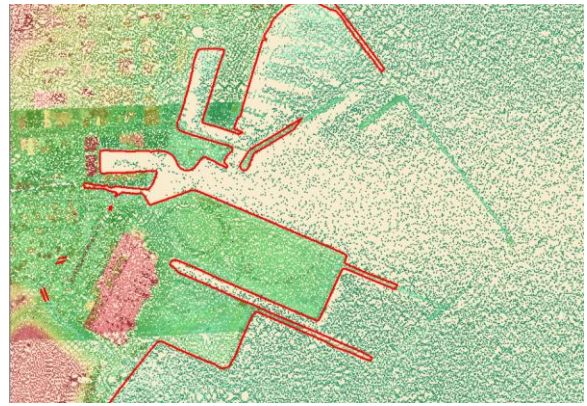
- Breaklines in the city of Port Washington have been terminated leaving the breakwater wall classified as water and/or non-ground. Continue breaklines along these features and re-class to ground. Below is area of concern with 2015 Ortho with breaklines in red and also LiDAR point data by elevation with breaklines in red of the same area.

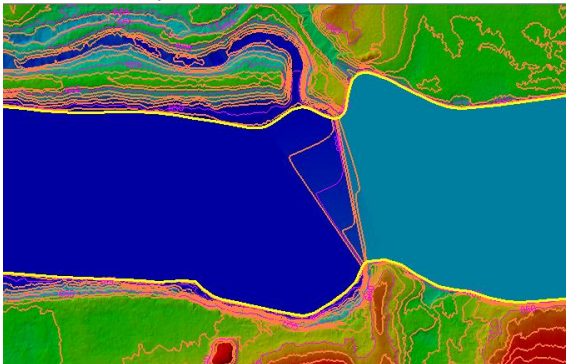
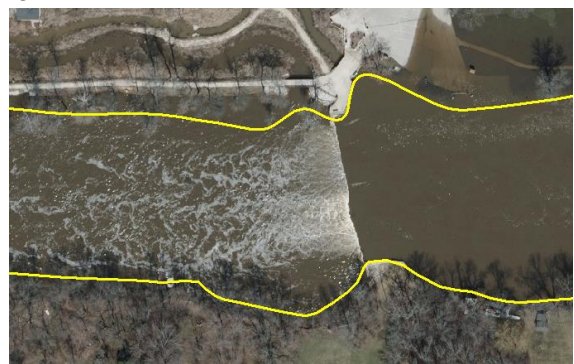
- Breaklines along dams need a line across the top and bottom and/or have closed polygons beginning and ending at the dam to properly enforce triangulation and minimize poor contouring around this hydro feature. See below demonstrating the issue.

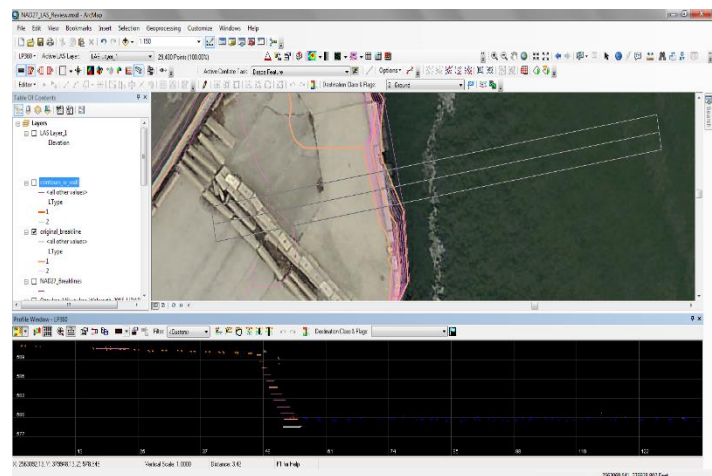
- Breaklines especially near walls have significant issues. The first issue is horizontal alignment accuracy. Most wall breaklines were collected well inside of the wall surface itself (i.e. breakline is placed in the water). The horizontal placement ranges anywhere from 3 – 10 feet off of apparent location which is cause numerous issues on the contour generation. Shown below is a location with both horizontal error and how the contouring looks when the breakline is enforced. The measured horizontal error on this sample below is 4.6 feet. The second major issue is the need to create a second breakline due to the significant vertical change and assurance of proper contouring around these features in meeting National Map Accuracy Standards. This second breakline allows proper enforcement and characterization of the topology around these specific wall features. The screen capture below shows what the contours look around this area. The Commission edited the existing line to locate it at the base of the wall itself and placing the breakline at the water surface of 580.0. The second breakline was created using LP360-retaining wall conflation tool.

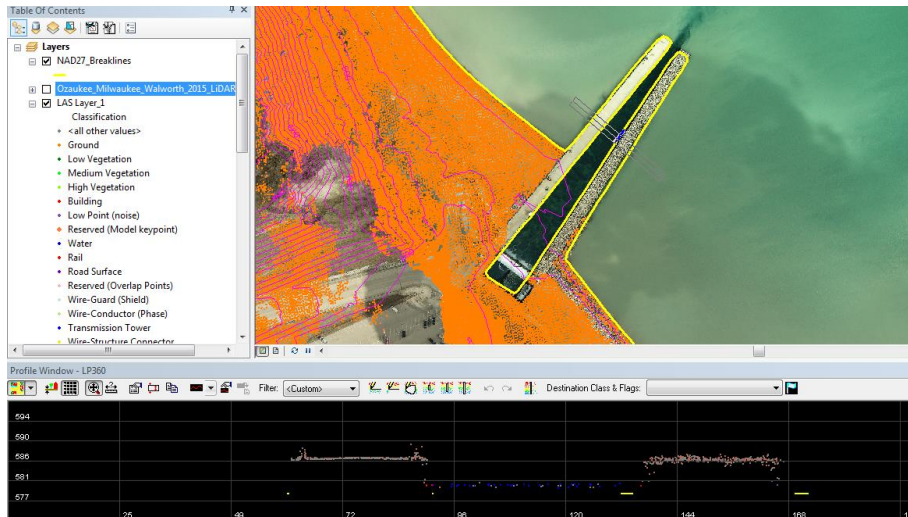
- Missing ground points and model keypoints. Need to put ground points back in surface supporting walls around collected breakline below.

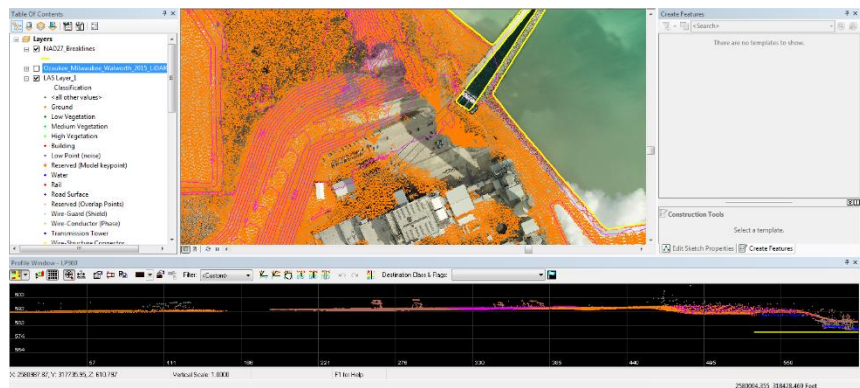
- Missing ground points around power plant. Smoke was causing a major ground obstruction on the primary flight line but the neighboring flight line(s) covered the ground well. Need to re-run ground around plant area to properly classify terrain. This mis-classification edit call was not in the shapefile but location was near the edit call location for ground points along the shoreline wall discussed above.

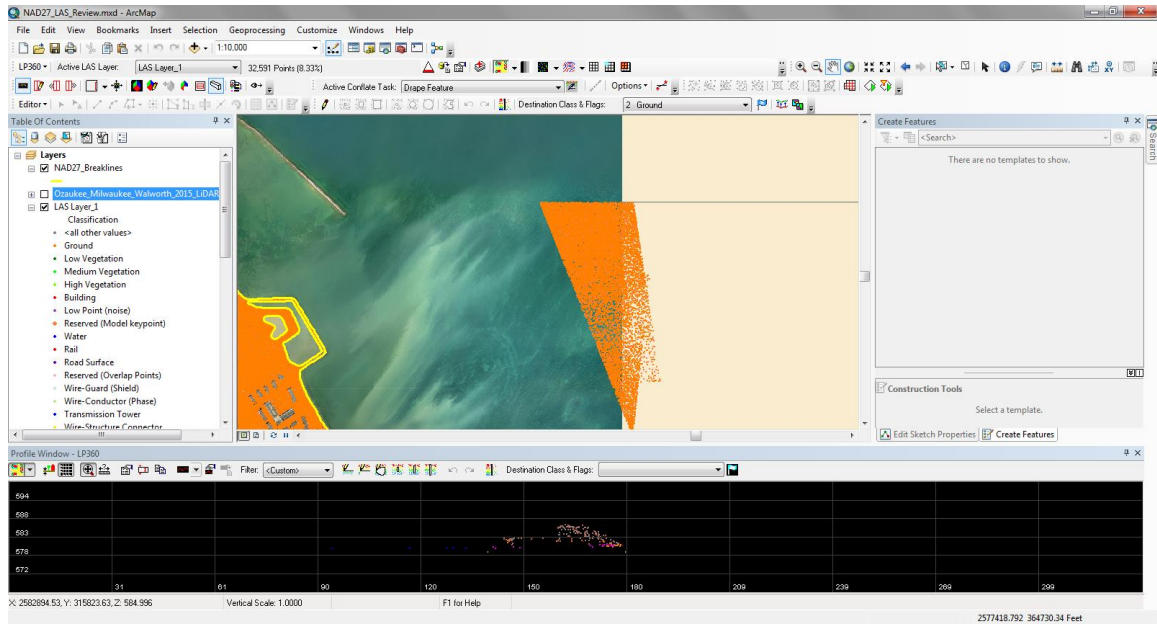
- Water points that were classed as ground. Need to re-classed points to water. These points are the tiles along Lake Michigan shoreline and are well out in the lake

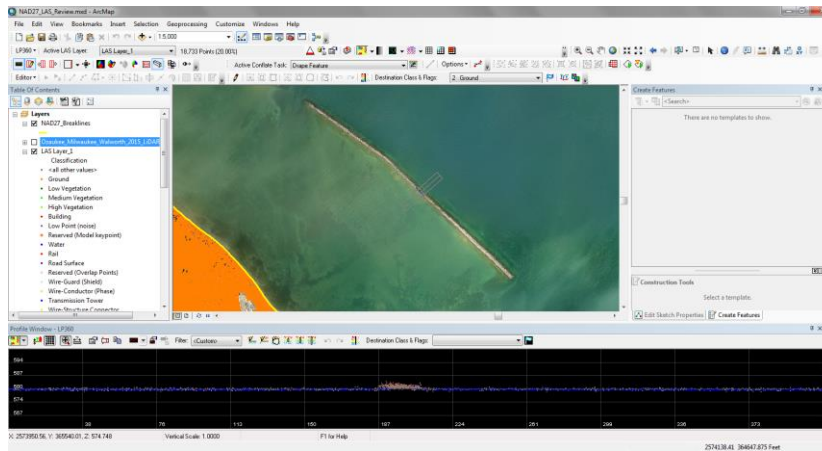
- All break water walls located along the near shoreline of Lake Michigan have been omitted. These wall need to be collected and a breakline captured around it consistent with the elevation of the shoreline for proper triangulation and contour generation for these missed features.

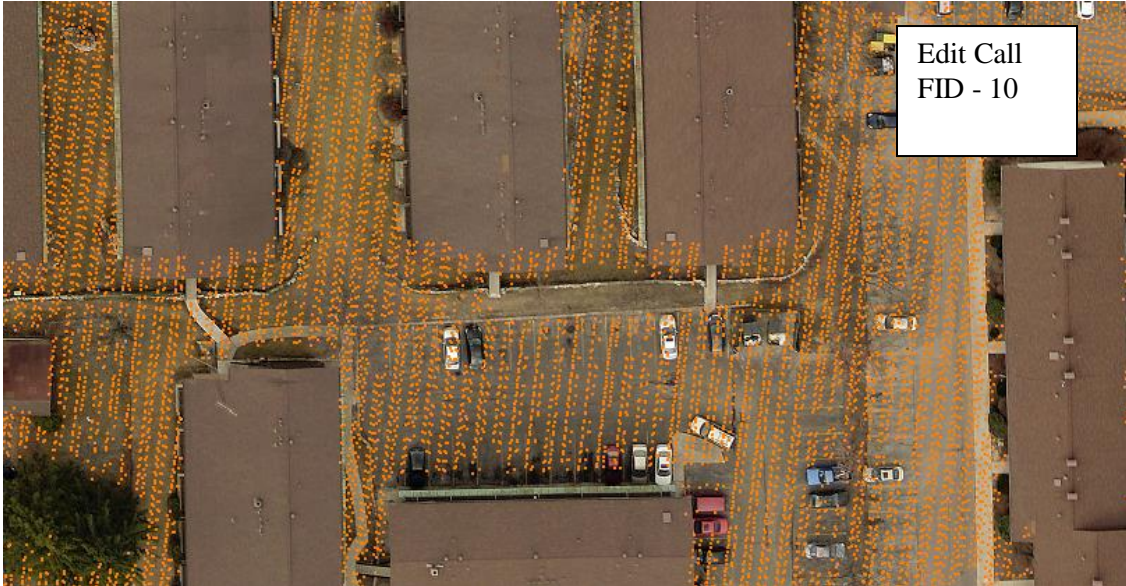
- Ground points missing causing the contouring to be affected.

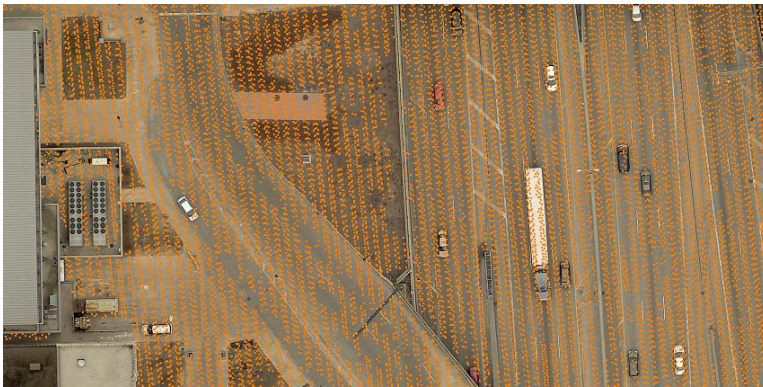
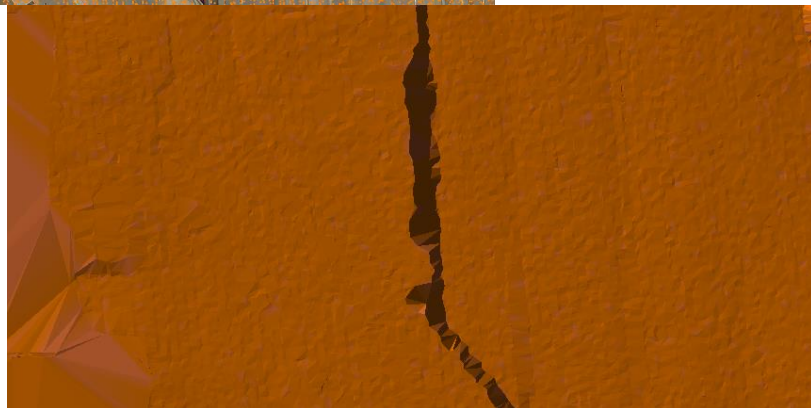
- Missing ground points along a transportation wall that affects contouring and DTM surface modeling. See below regarding a sample effect of the ground macro peeling back the ground points along a vertical feature.

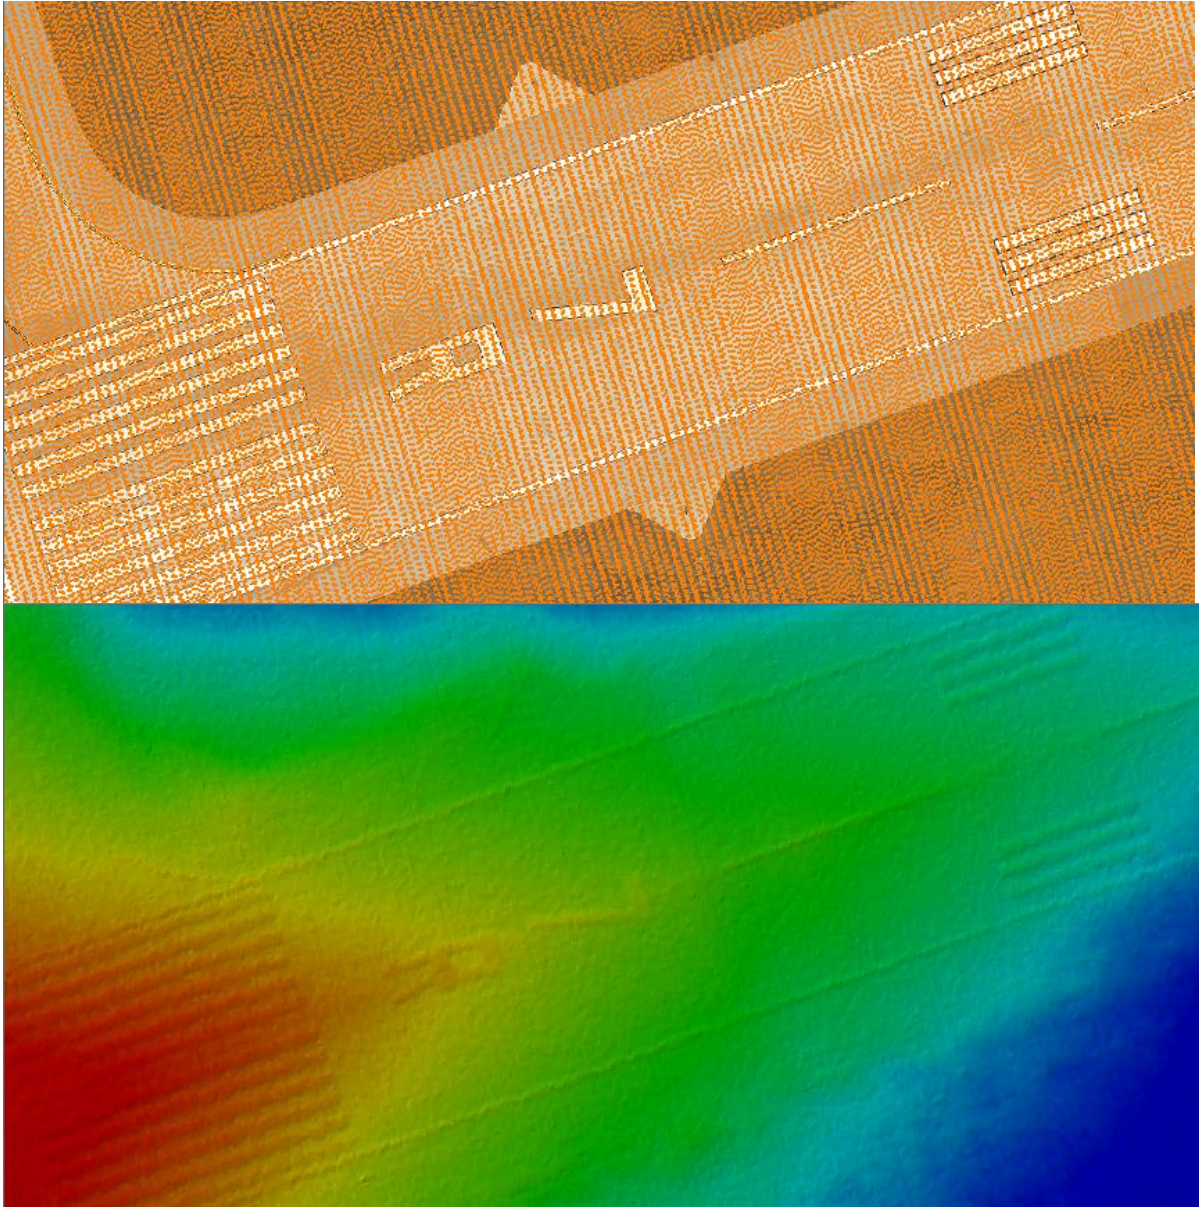
- Runway stripes seem to float above the average ground terrain based on the super reflective surfaces. See below of an example of the runway bias.

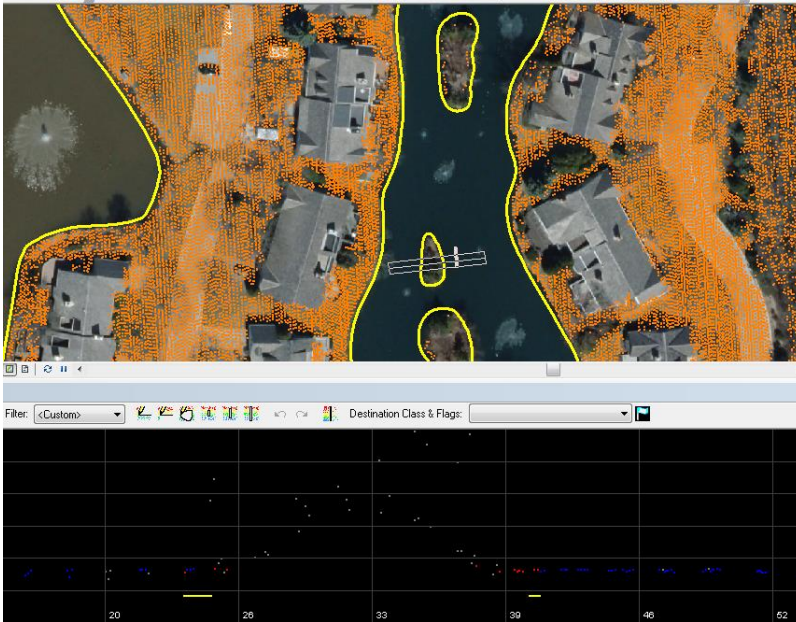
- Missing ground points in island breakline. Breakline capturing an island has been compiled but the ground points are missing. See below for an example.

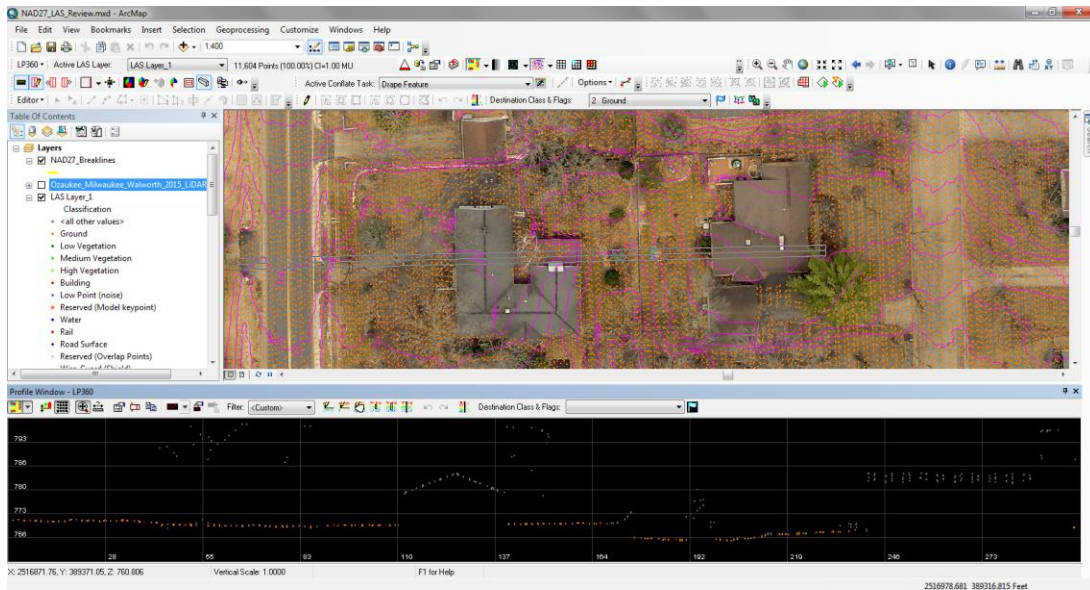
- Some minor deck points in the QC review were found but overall the deck points were eliminated. Please look to clean up the QC deck call made on both files.

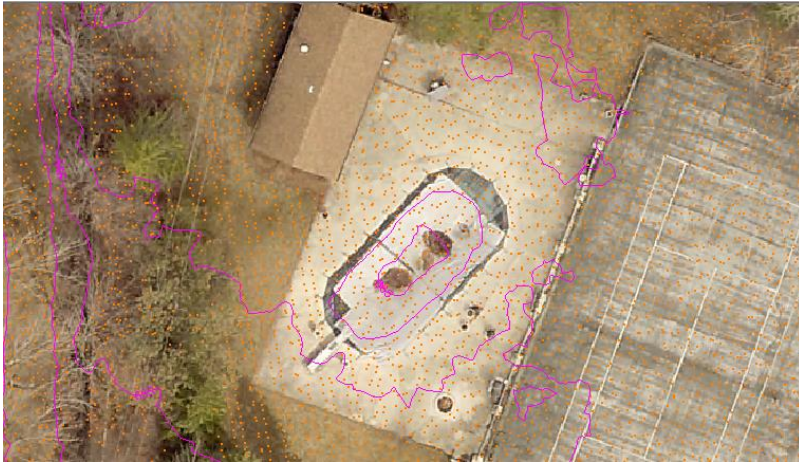
- Ground points in pools. In our 10% review we found a few pools that affected the contouring around a specific pool which the ground points should be removed. Below is a screen capture of the contouring affect with the pool. Edit calls were only made where ground points in pools affected the contours.

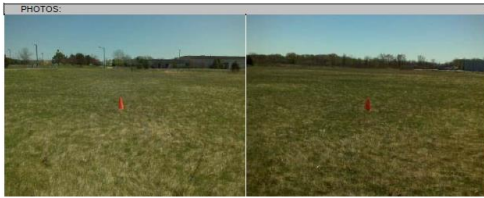
Example 1

3. Each point location and quality data sheet had associated images of the type of land cover feature it supported. Based on the images, it was found that several images were inconsistent with the type of feature they were supporting. The first example found on the second page of this report documents that the land cover category specified was “Tall Weeds”, and Examples 2 and 3 were considered “Forest” points.

Please review associated images to ensure proper labeling of land cover types prior to completing the Vertical Accuracy Report according to FEMA guidelines.

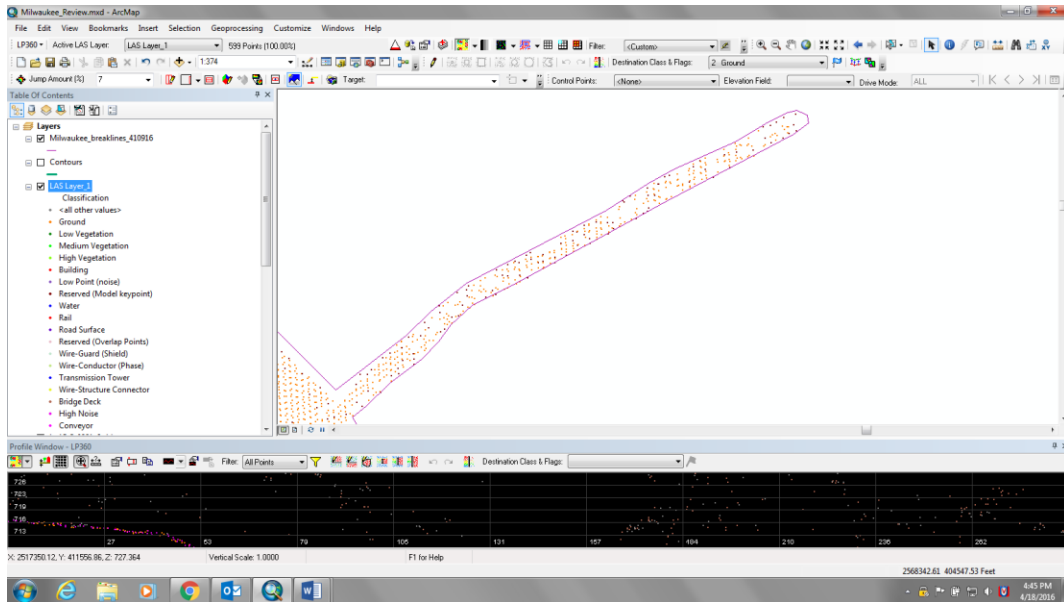
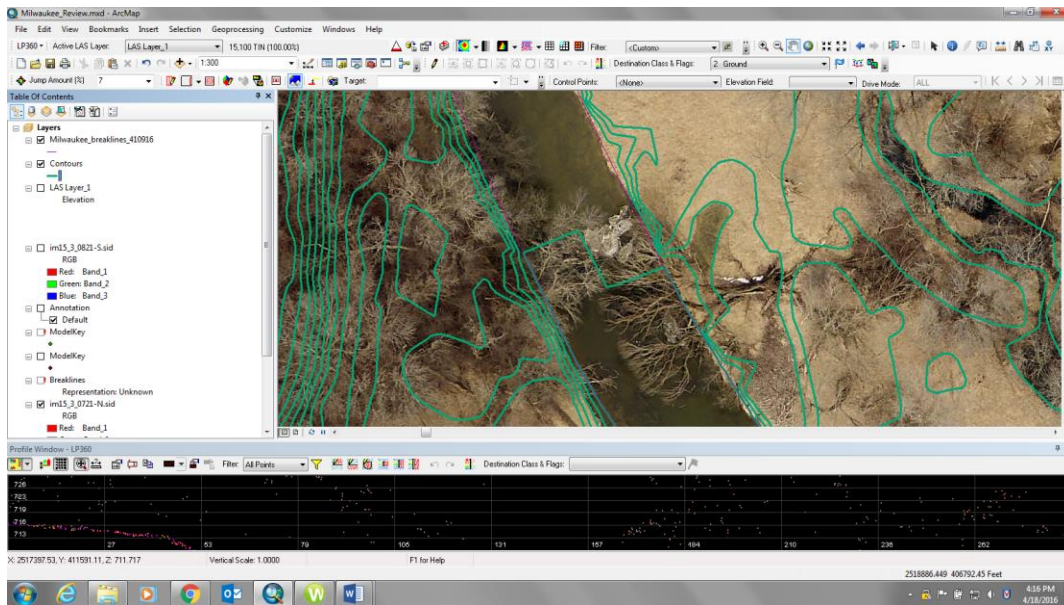
Points outside of breakline. Shoreline has points cleared but the breakwater wall did not have any points cleared away from breakline.

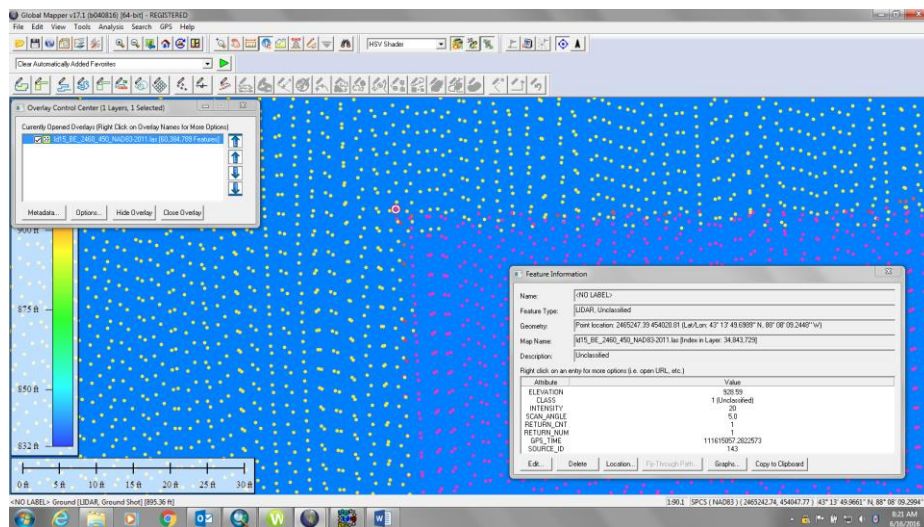
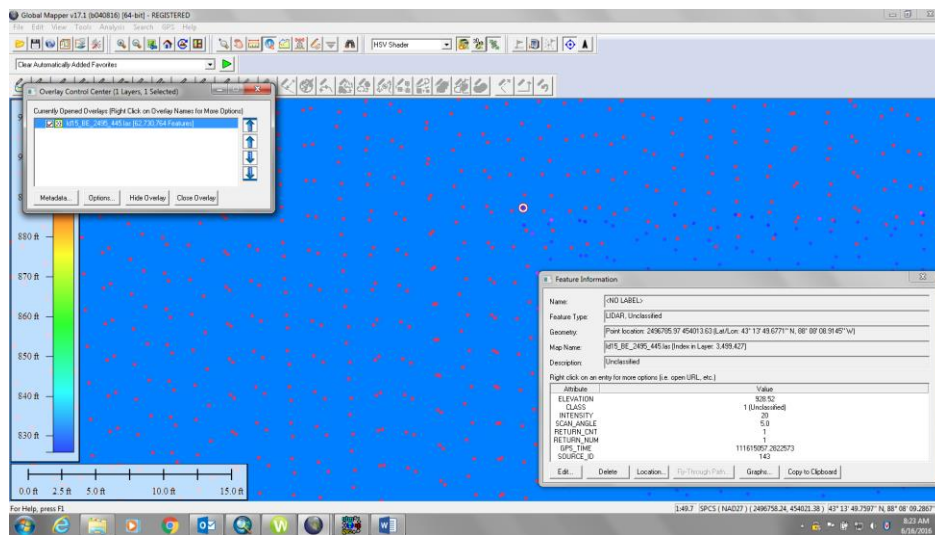
ND83/2011 TILE (Id15_BE_2460_450_NAD83-2011.las)

Converting from NAD83/2011 to NAD27, the sample point computed found is inconsistent between datums:

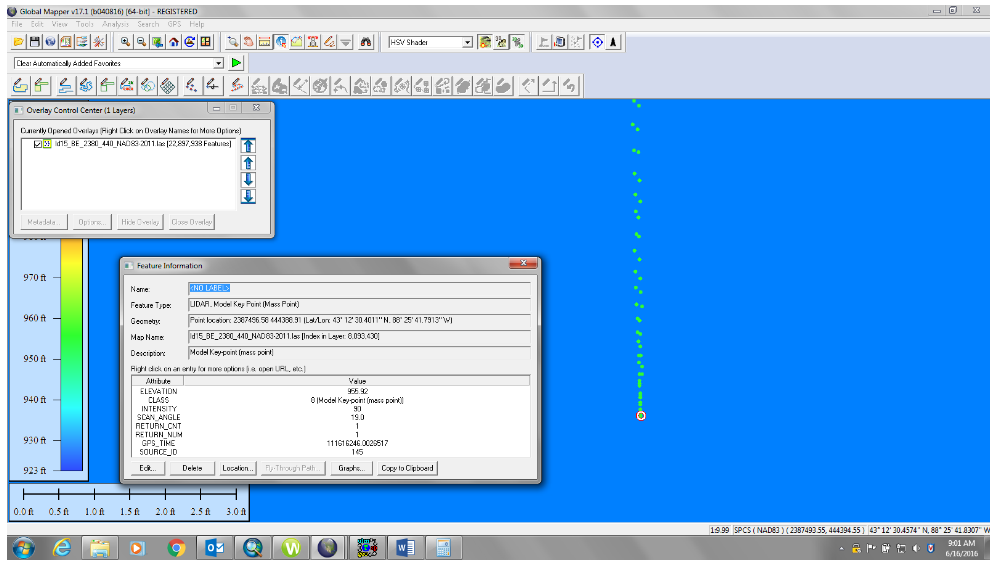
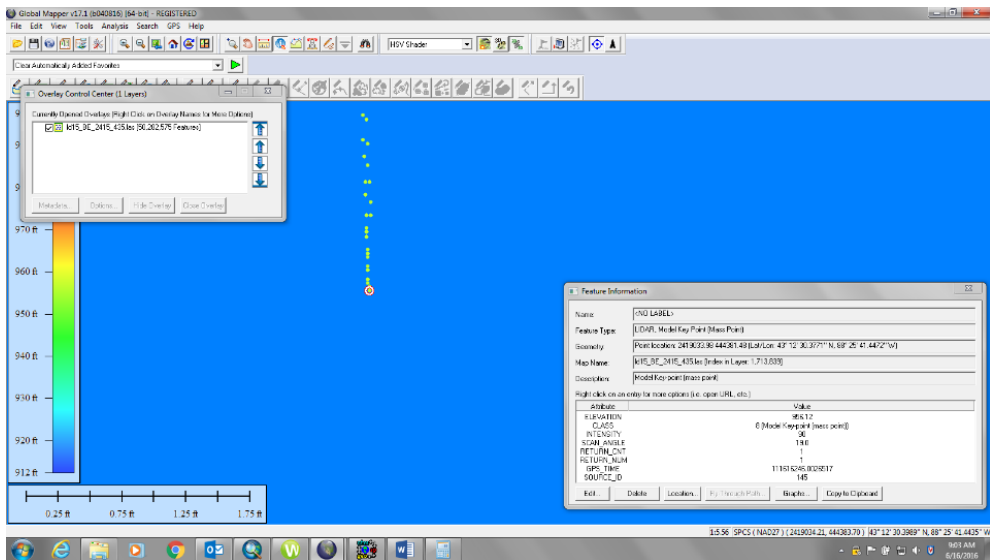
NAD83/2011 Tile (Id15_BE_2380_440_NAD83-2011.las)

Converting from NAD83/2011 to NAD27, the sample point computed found is inconsistent between datums:
