LiDAR Quality Review Report

Burnett County, Wisconsin
Land Information Office

September 2016

PointCloud Mapping, LLC

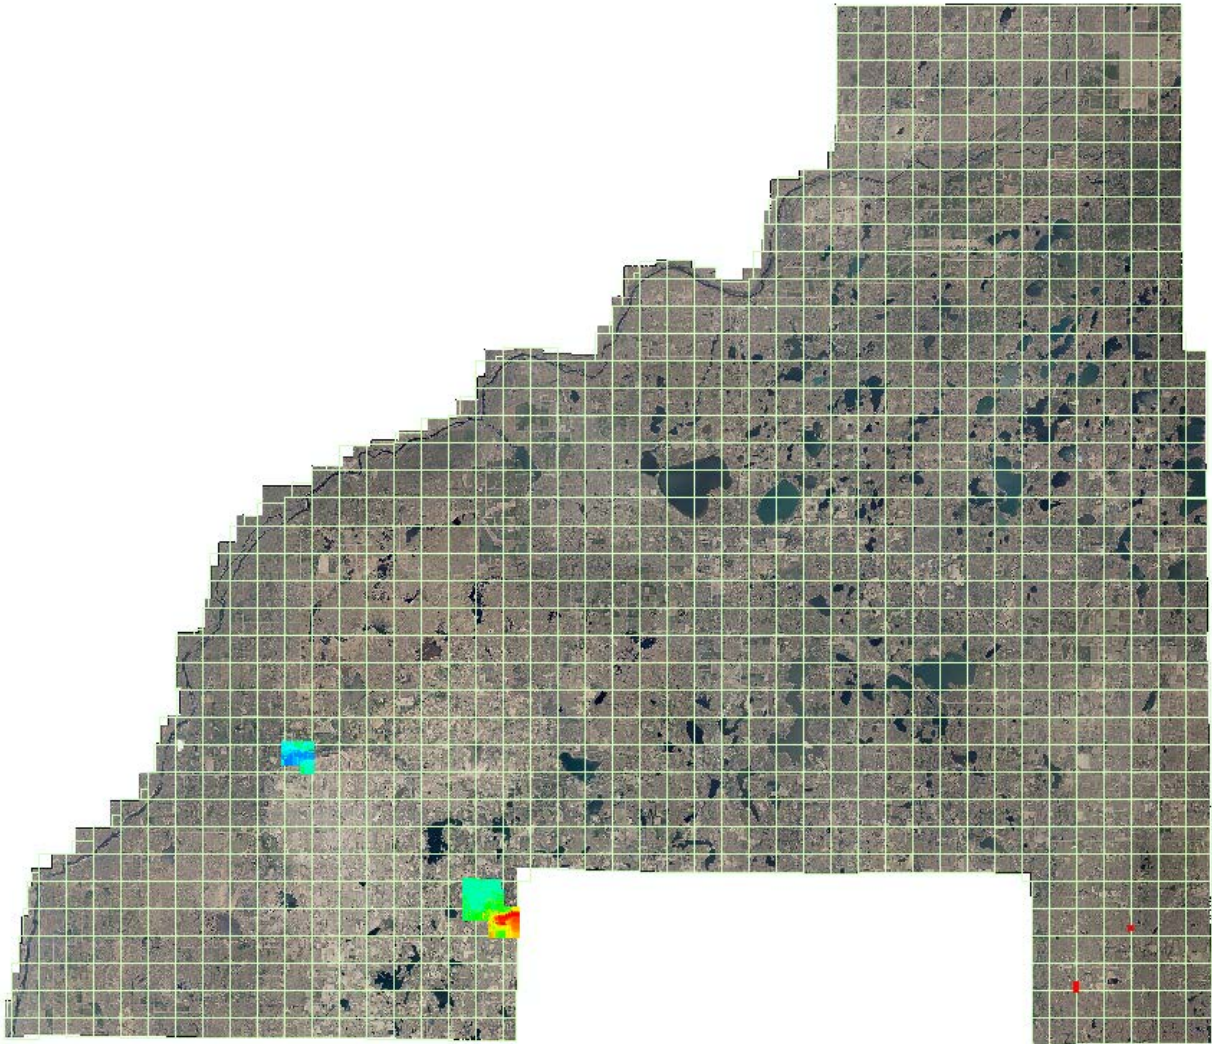
Figure 3 – Duplicate Points

During an automated routines to check for duplicate points, it was noticed that 10 tiles had duplicate points ranging from counts of 1 to 4,861,622. These tiles are detailed in the “Burnett County Lidar Review 1-12-16 v2.xlsx” document. A similar situation exists for the Bare Earth las delivery. These duplicate points were removed from the data set.

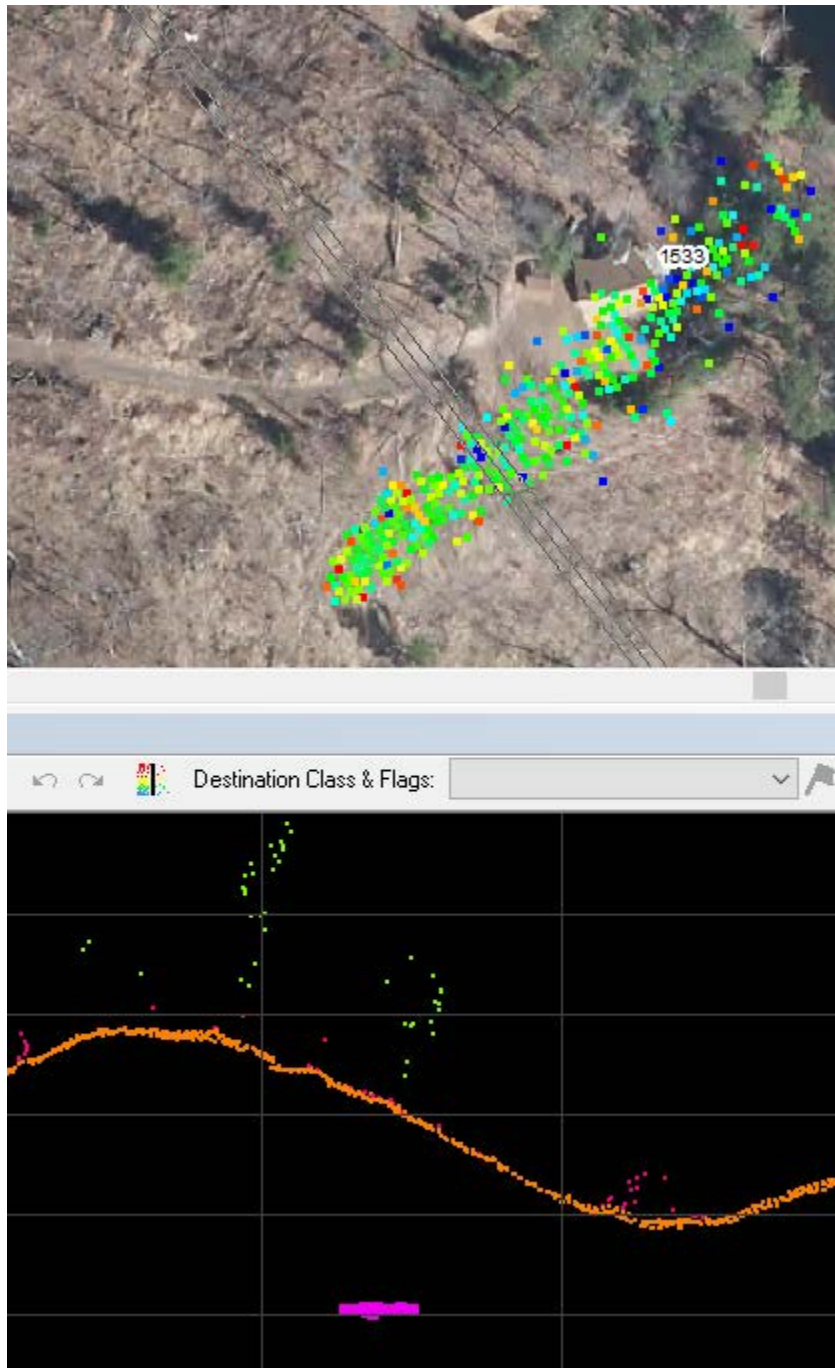
Figure 4 Class 18 Points

Tiles 1533, 3126, 3742, 3942, 3943, 3940, 2937, 2822, 1633, 3840, 1738, 3844, 3845, 3127, 1142, 1543, 2338, 3228, 1531, 1736, 1740, 3541 and 3941 contain Class 18 points. Figure 4 is an example of tile 1533, in plan and profile view, and the Class 18 points that fall below the ground surface. The traditional ASPRS numbering scheme uses Class 18 as high noise. Class 18 points were reclassified and placed in Class 7 (Low Points).

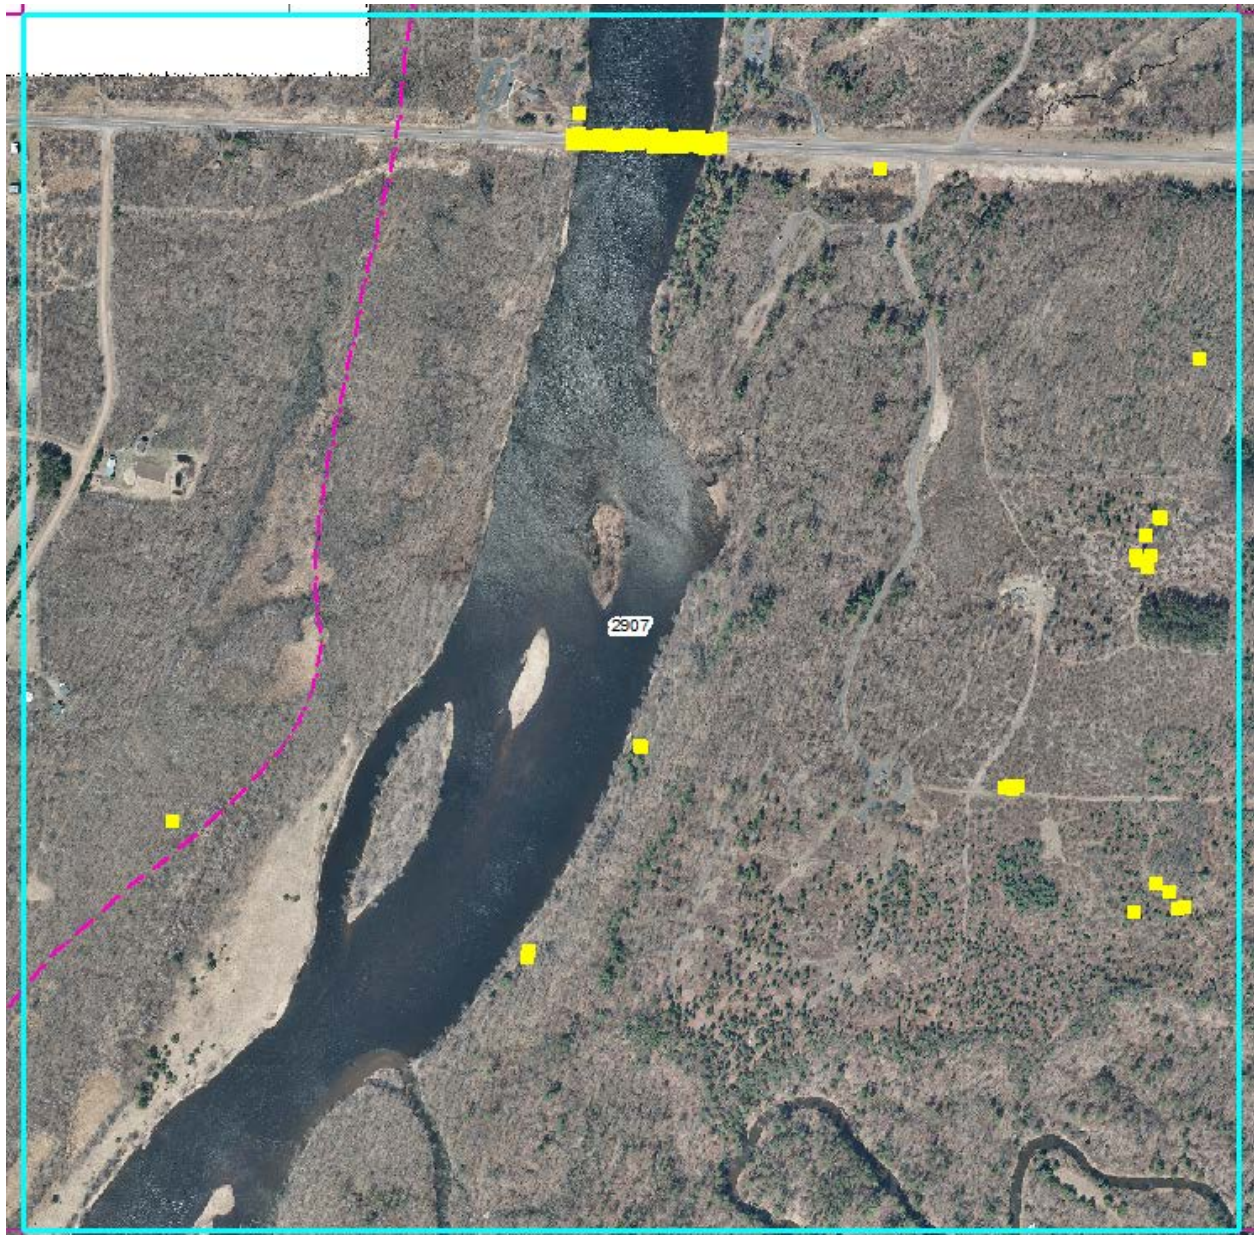
Figure 5 - Misidentified Bridge Points

Figure 5 shows Class 17 points on tile 2907. In the northern portion there is a correctly classified bridge spanning the river. All of the other points in yellow are Class 17 but do not represent bridges. These spurious bridge points on this, and other tiles, were corrected.

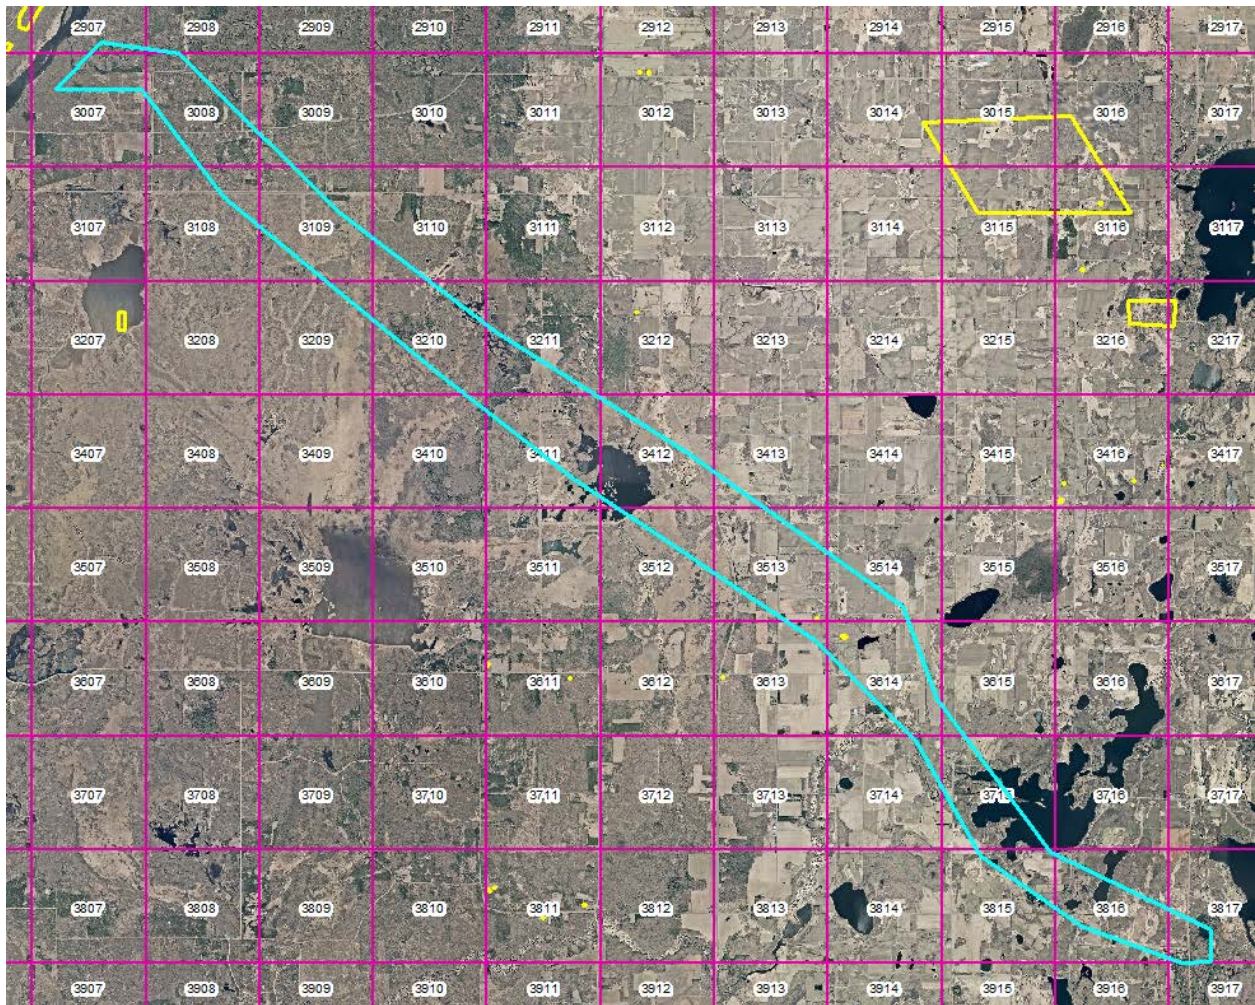
Figure 6 - Missing Overlap Between Flight Lines

The following figure shows the area where north-south flight lines do not overlap the diagonal flight lines. The reason for having overlap between flight swaths is to 1) minimize the chances of having data voids and 2) allow the contractor to clip the outside edges of each flight swath where errors are most likely to occur. It is quite common to trim the data at the midpoint between adjacent flight swaths. In this particular case, Ayres clipped the flight swaths to a common line to make a butt join. While this is a bit unusual, it still passes the accuracy and point density standards.

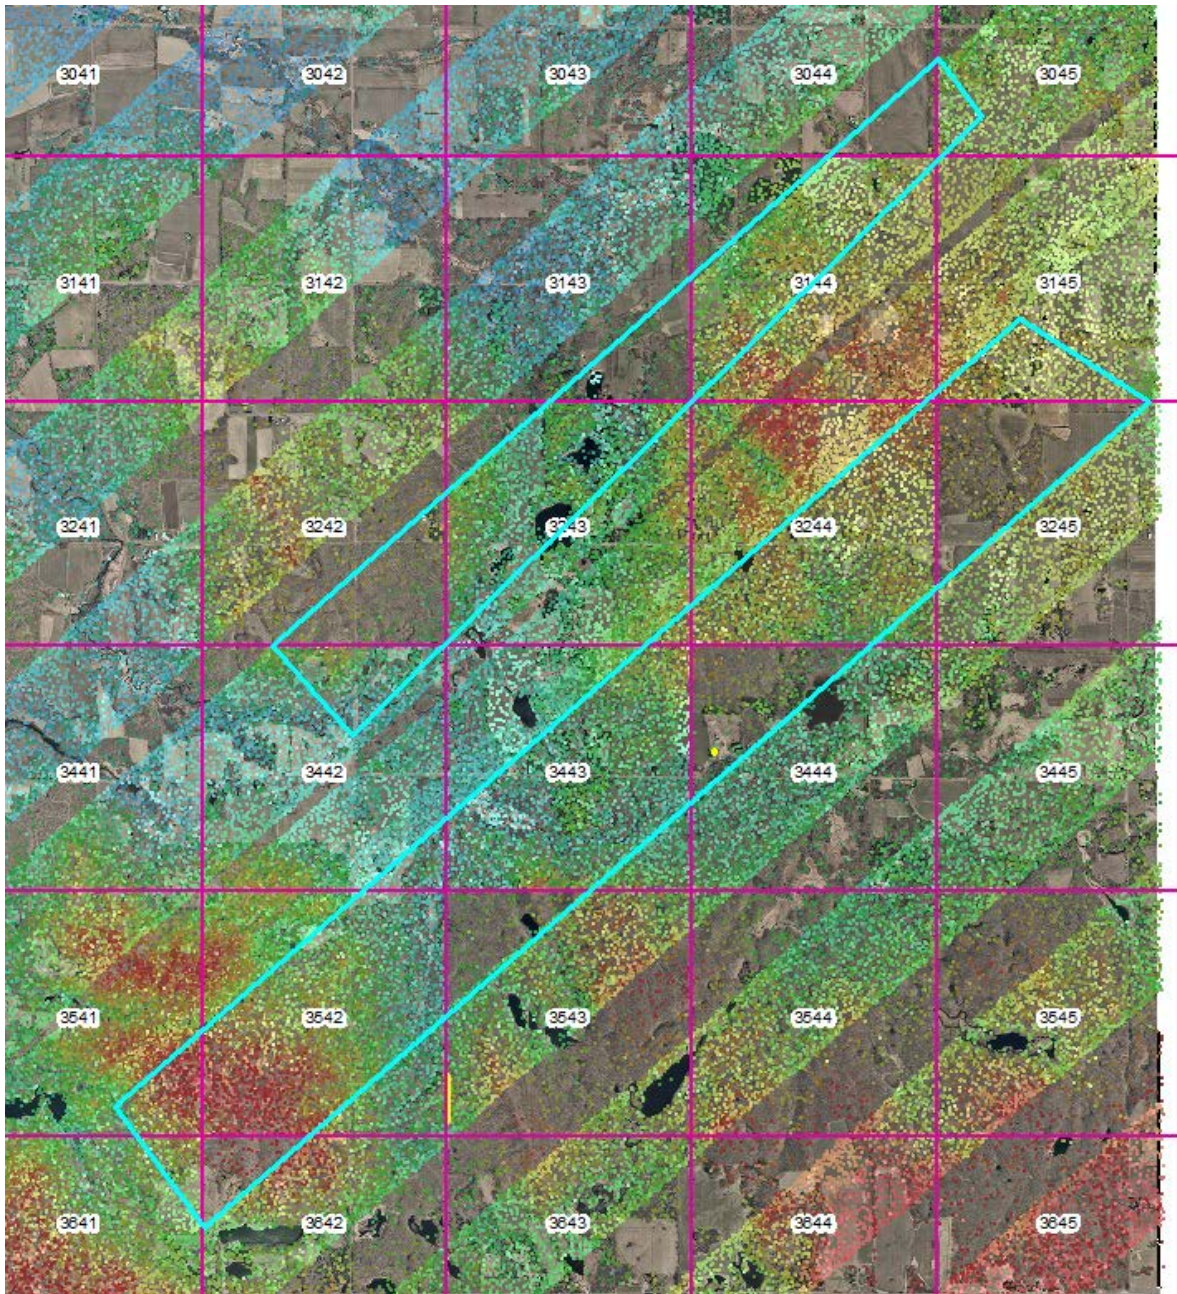
Figure 7 - Gaps in Coverage

The following figure shows incomplete coverage in the corners of various tiles. The below figure shows Class 11 points (Withheld) to emphasize the unusual coverage in the corners of the tiles. As previously discussed, the normal process is to trim the overlap at the midpoint between the flight swaths. In this case it appears that the trimming was done periodically along the tile edges. The data coverage is complete and passes the accuracy standards and point density requirements, but the method used to trim the overlap area is unusual.

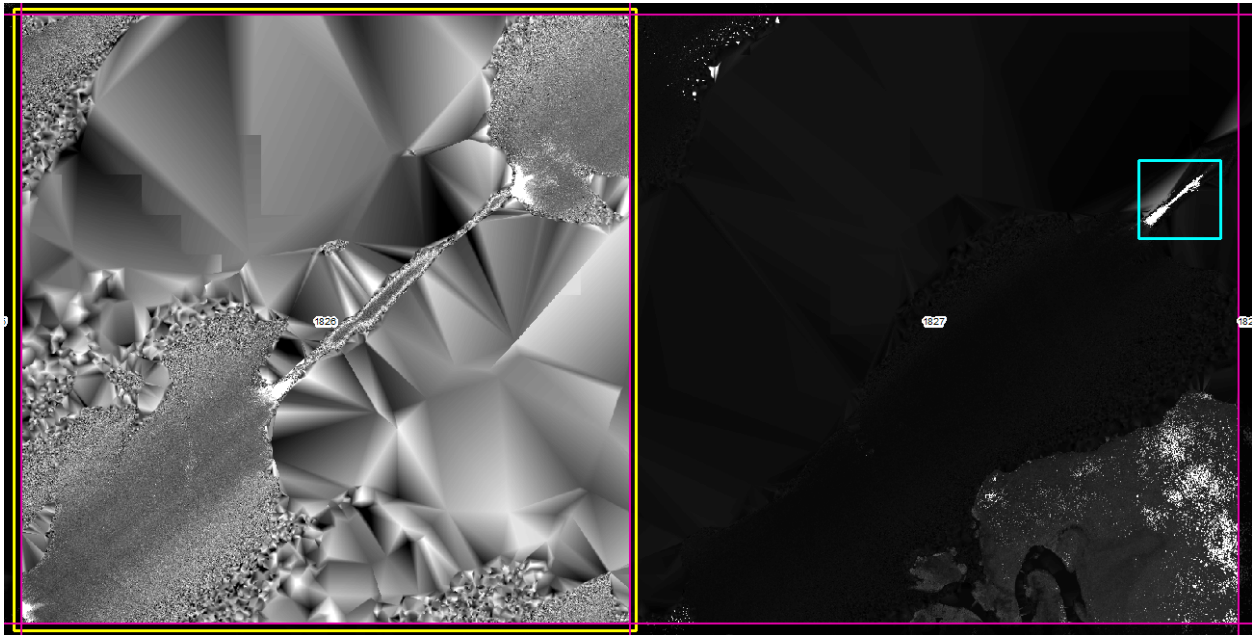
Figure 8 - DSM Issues

In Figure 8, the tile on the left the DSM contains elevation differences of 42 feet in a tile that only contains water. This comes from using Class 1 (Unclassified) points when generating the DSM. Since Class 1 contains anomalous points, it should not be used in the generation of other products. The tile on the right contains elevations that are 45 feet higher than the water surface from the Class 5 (High Veg).

With minor modifications, by Ayres, to the DEM's, DSM's and Intensity images, the final products passed the specifications.

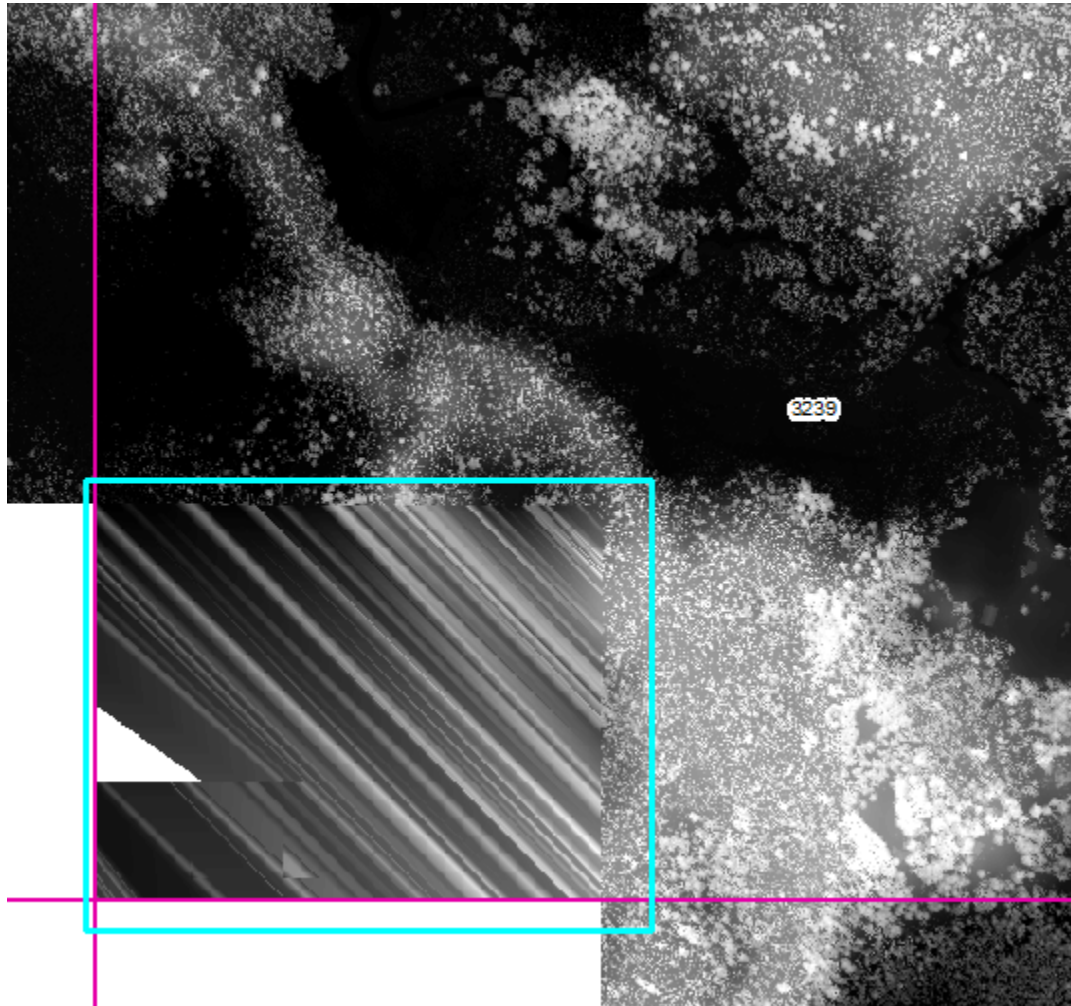
Figure 9 - DSM and DEM Corner Issues

In Figure 9, there is a portion of the DSM and DEM at the corner that interpolates across the corner and provides incorrect elevations. All DEM's and DSM's were clipped to the project boundary and these corner issues were corrected.

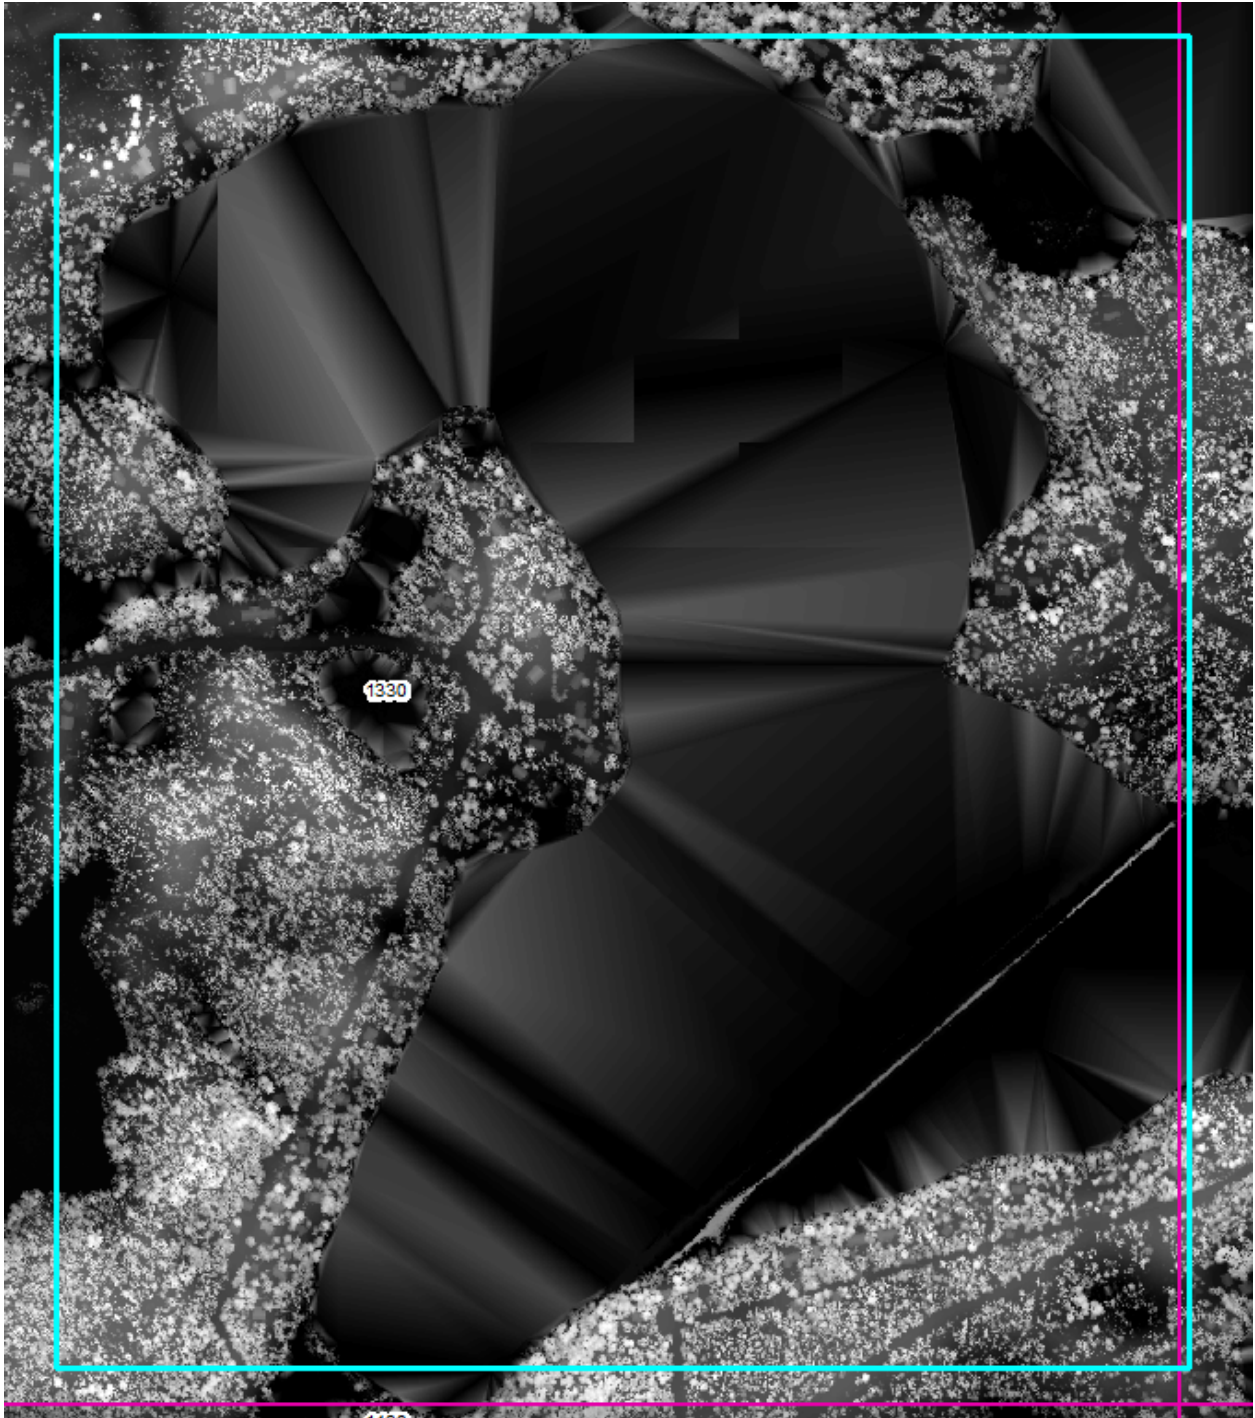
Figure 10 - DSM Issues in Water

In Figure 10, the DSM contains triangles in the water. Apparently, points located in Class 1 are being used to generate the DSM and contains tree tops overhanging the water's edge. There can be two slightly different approaches to create DSM's along water bodies. First, you can select the first returns from the entire dataset. This would include trees that are overhanging the water body and thus create triangles in the water and the TIN triangles connect across the water body. This creates false elevations above the water. The second approach is to use the hydro enforced break lines to clip the overhanging trees and use the break lines to make the water "flat". This presents a more aesthetically pleasing DSM but it omits the overhanging trees. Both alternatives are technically correct and Ayres chose to use the first option. In addition, the strip in the SE corner of the tile is from erroneous points contained in Class 1. This error was corrected in the final data set.
