Ground Control Report

Wisconsin WROC - 3DEP | Jefferson County Lidar 2019

1.1 Ground Control Design and Methodology

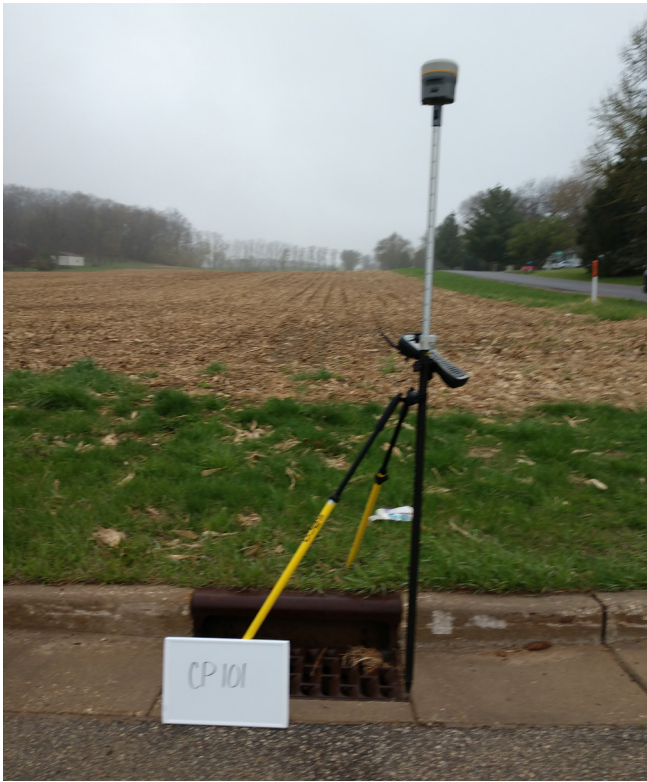
Point 101

PNT	CODE	RH	PICS	Location
101	CP	2M	✓	NE corner of invert in SW corner of intersection of STA 89 & Clarkson Rd. Invert is in Southbound curbline
DG4481-1 Waterloo GPS (Check shot) $\Delta N: -0.034'$ $\Delta E: -0.017'$ $\Delta V: -0.012'$				
102	CP	2M	✓	Very corner of far NW corner of driveway, 12.4' S of CL

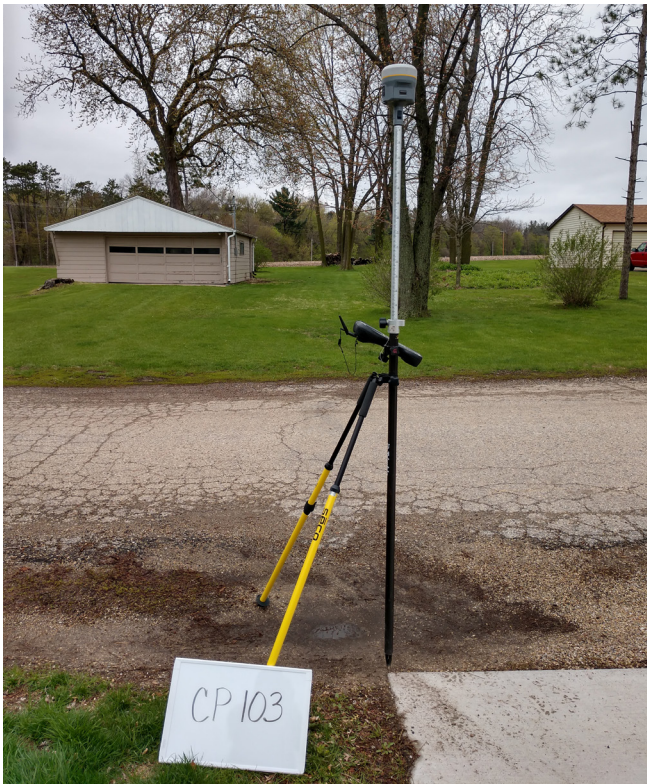
Point 103

103	CP	2M	✓	SW corner of concrete parking pad of W9667 Lake Dr.
DF9997 Busseyville GPS (Dual 180°)

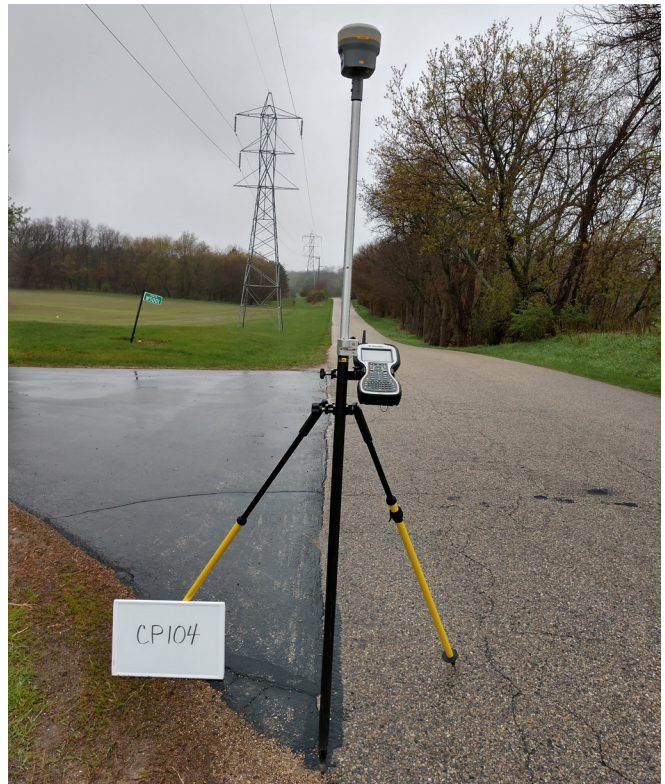
Point 104

104	CP	2M	✓	Eastern tip of driveway where it meets Young Rd. (W5001 Young Rd.)
DF9993-1 CK on Palmyra GPS (15 sec) $\Delta N: 0.001'$ $\Delta E: -0.004'$ $\Delta V: 0.002'$

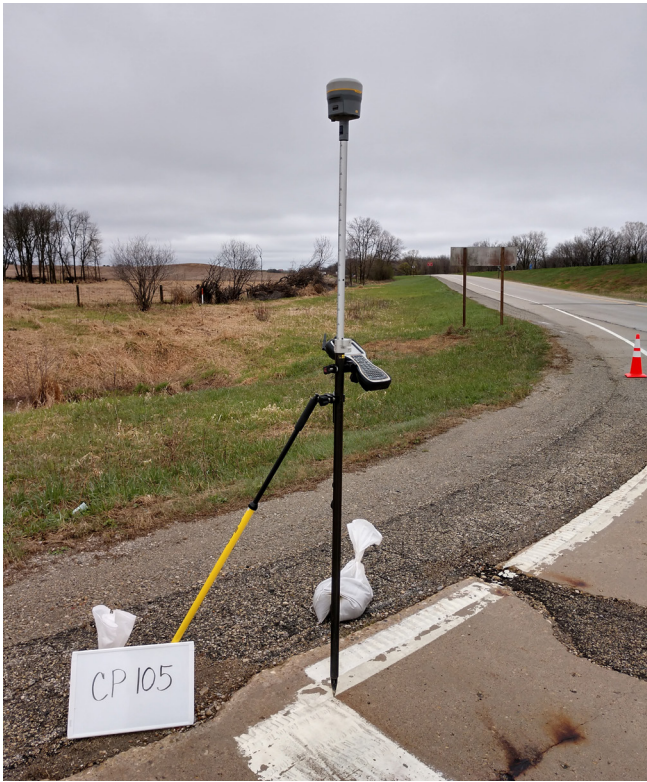
Point 105

PNT	CODE	RH	PICS	Location
105	CP	2M	✓	Junction of fogline & stopline at end of I-94E off-ramp Willow Glenn Rd. turning south.
DF9620 Sullivan N GPS (Dual 180°) *NGS Data Sheet coordinates off by 6.5' East + 1.5' South $\Delta N: 0.002'$ $\Delta E: 0.002'$ $\Delta V: 0.025'$

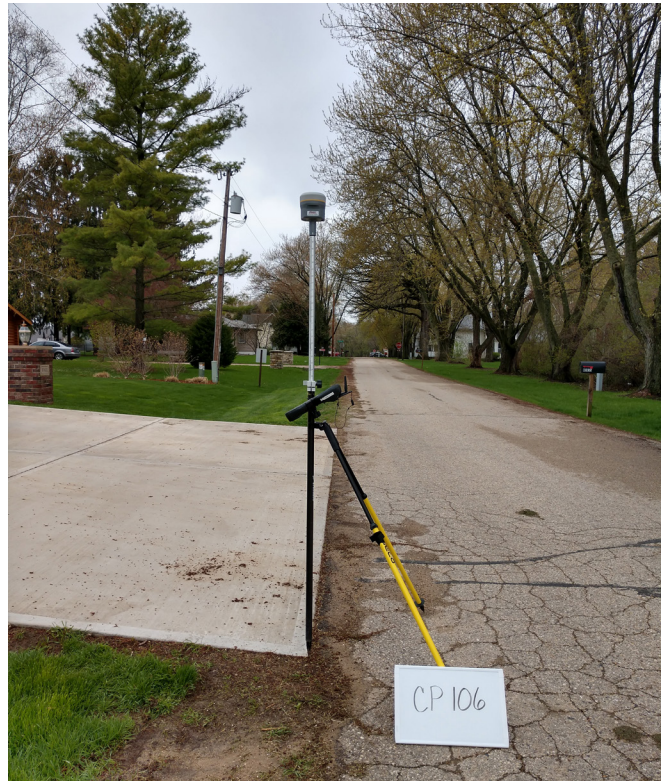
Point 106

106	CP	2M	✓	NE corner of concrete driveway of W9655 E. Main St.
-----	----	----	---	---

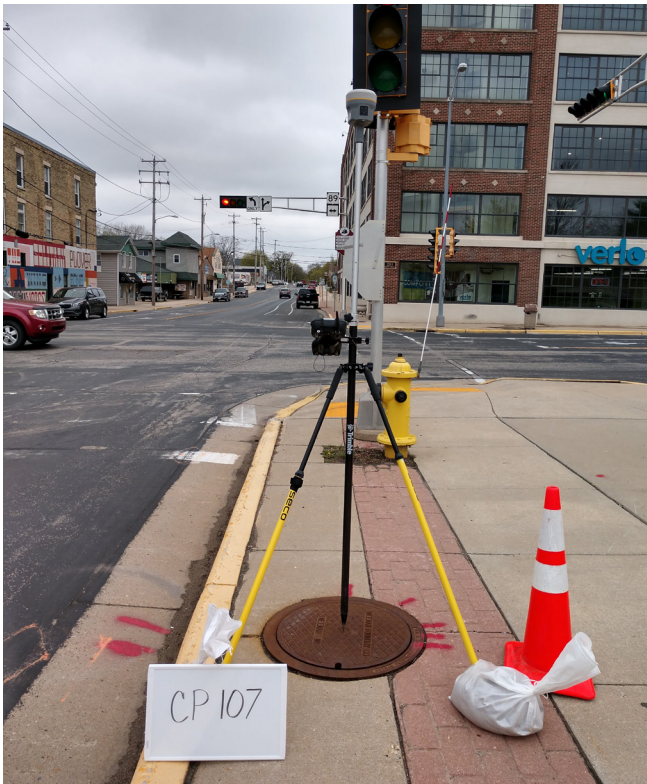
Point 107

107	CP	2M	✓	Manhole in sidewalk on NE corner of intersection of Sherman Ave + N. Main St. 1.66' from back of curb of W. Bound Sherman Ave. 10.05' E. of fire hydrant
108	CP	2M	✓	Manhole in center of Walton Dr at T-intersection @ Tratt St. (CTH N)
DF9608-2 CK on Ixonis N GPS $\Delta N: -0.023'$ $\Delta E: 0.046'$ $\Delta V: 0.005'$

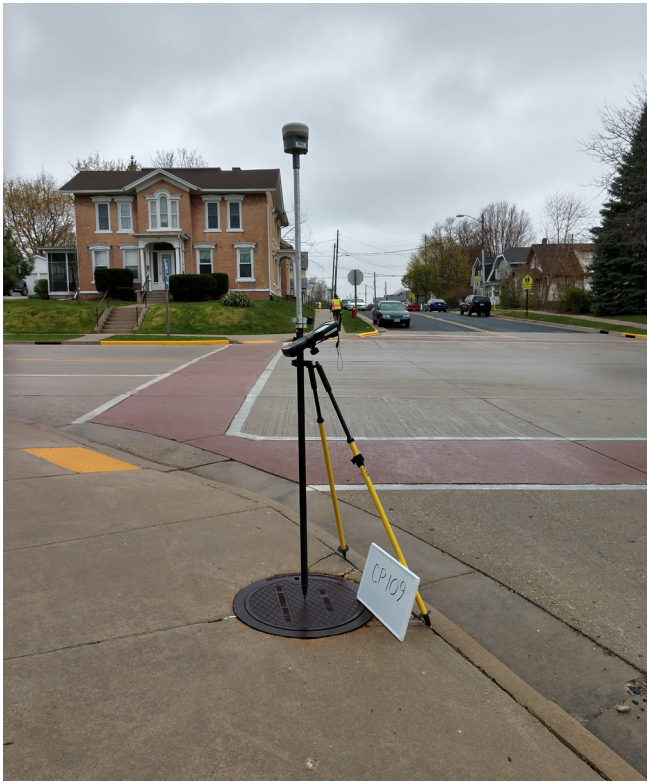
Point 109

109	CP	2M	✓	Center of manhole in sidewalk SE corner of intersection Cady & Church St. 36.1' south of CL of Cady St.
-----	----	----	---	---

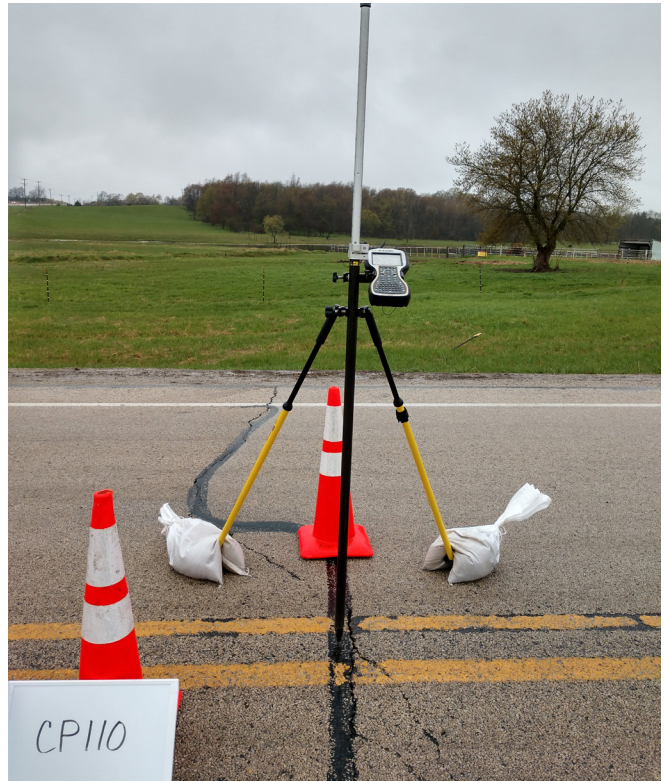
Point 110

110	CP	2M	✓	Crosspoint of CTH F centerline & far-line approx. 147' from Stop sign.
DF9993 - Palmyra GPS (Dual 180°) $\Delta N: 0.044'$ $\Delta E: 0.031'$ $\Delta V: \text{Cut } 0.009'$

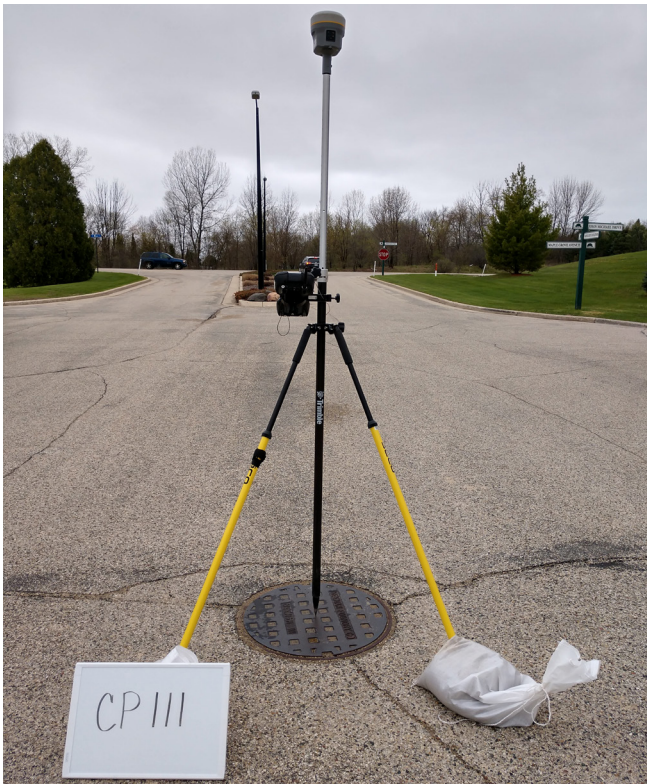
Point 111

111	CP	2M	✓	Manhole; Center of Maple Grove Blvd @ intersection @ John Michael Dr just east of intersection,
DG3890 Oakland E GPS (Dual 180°) $\Delta N: 0.005'$ $\Delta E: 0.007'$ $\Delta V: 0.008'$

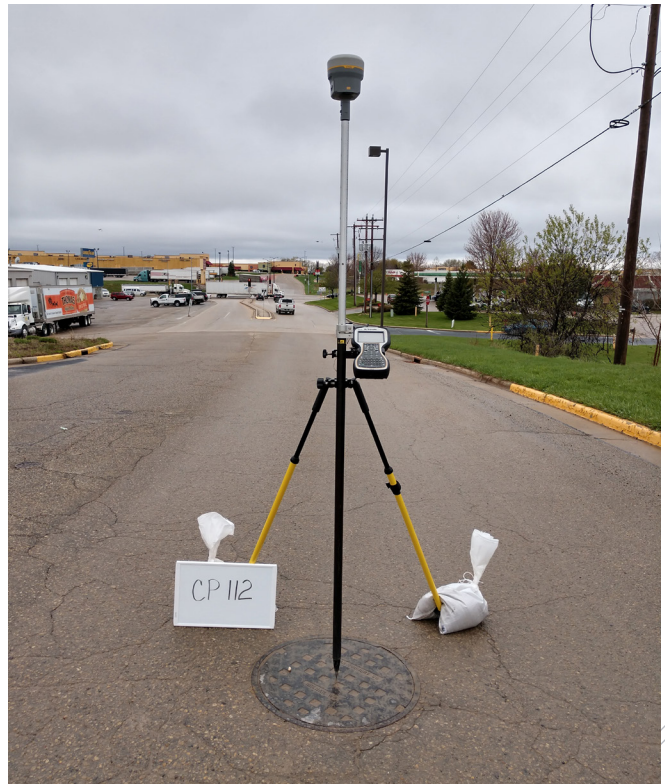
Point 112

112	CP	2M	✓	Manhole at intersection of Linmar Ln + Glover Ln (Westbound lane of Linmar Ln.)
-----	----	----	---	---

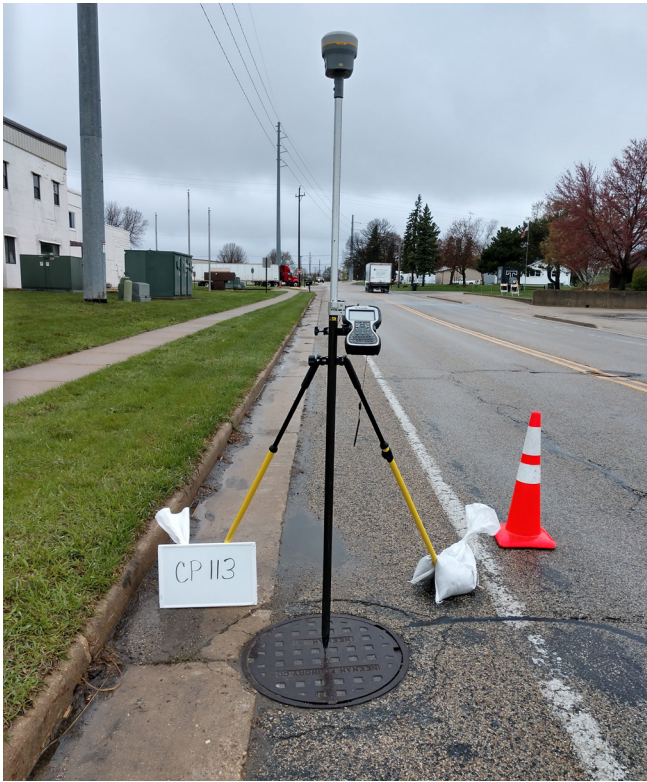
Point 113

113 CP 2M ✓ Center of manhole
2.87' from eastbound curbface of Tyrone Park
Rd. (HWY) + 14.45' south of CL

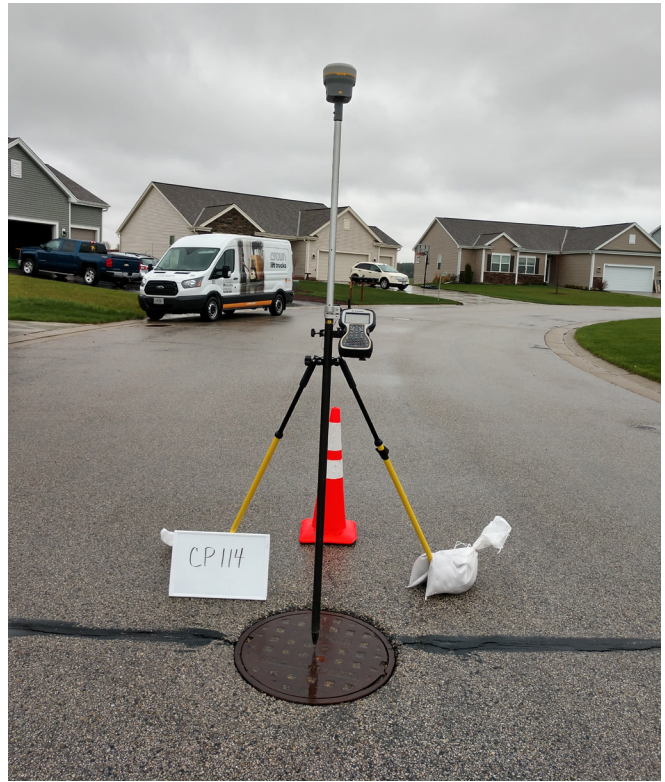
Point 114

114 CP 2M ✓ Center of manhole
in middle of Timber Ridge Dr. between N8024 N8028
25.7' SSE of fire hydrant in yard of N8024

DF9608-1 Check on Ixonix NGPS (15 sec.)
 $\Delta N: 0.017'$ $\Delta E: 0.022'$ $\Delta V: -0.009'$

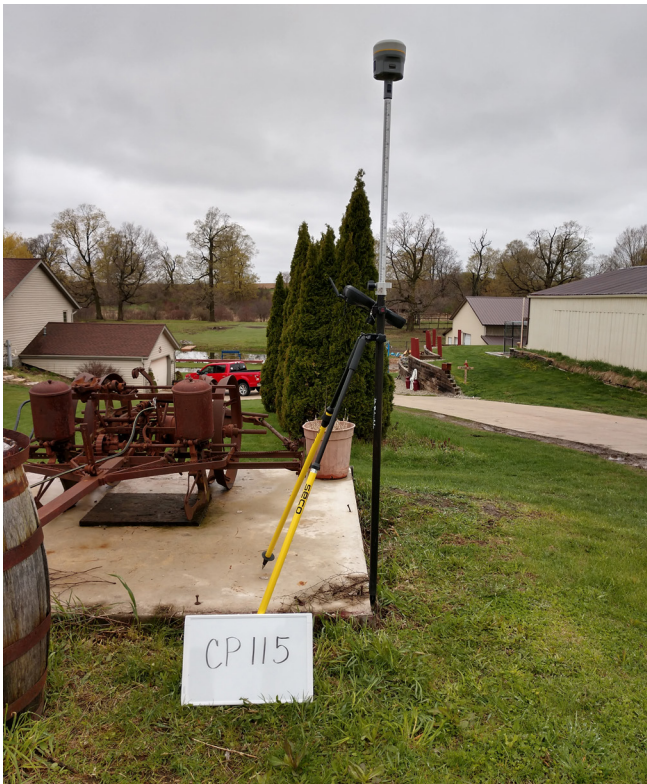
Point 115

115 CP 2M ✓ NE corner of
concrete slab southside of N4879 CTH P driveway
27.5' W of CL

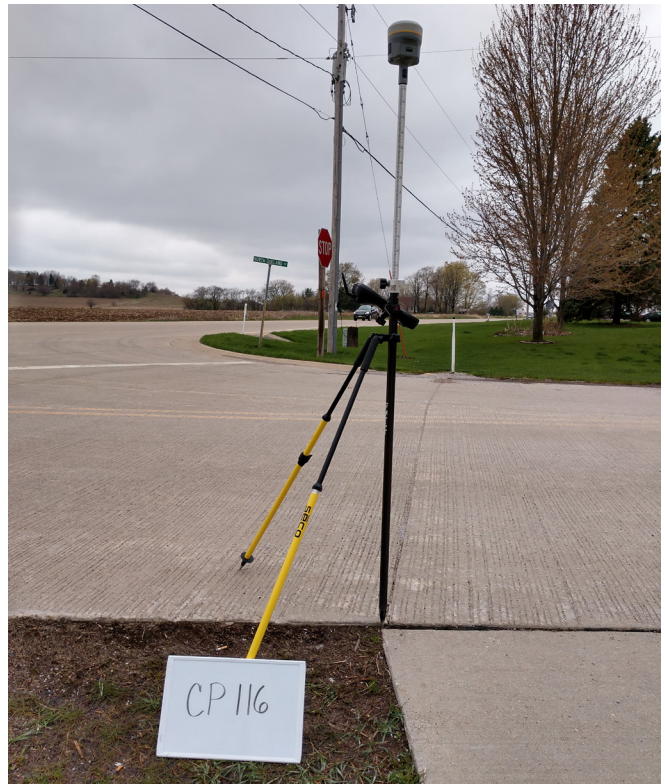
Point 116

116 CP 2M ✓ SW corner
of concrete driveway of N3634 N Oakland Rd.

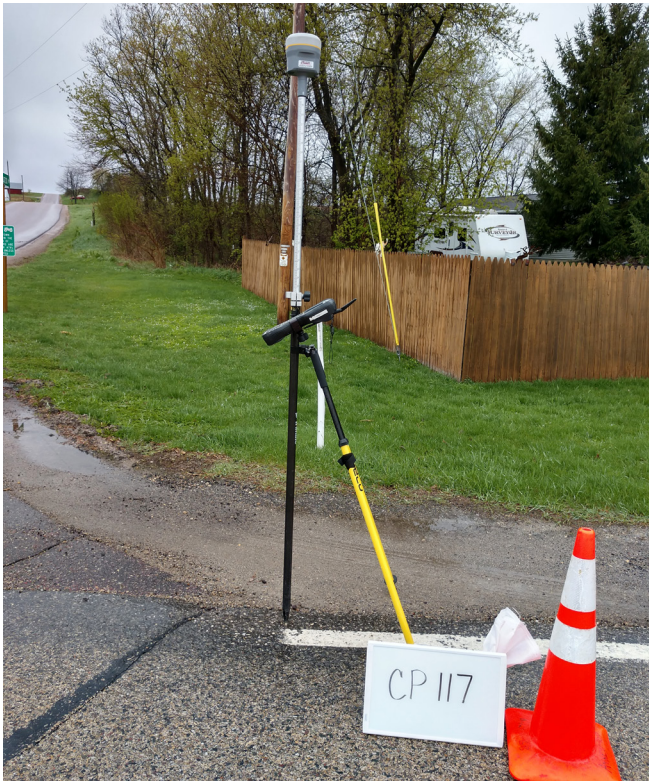
Point 117

117 CP 2M ✓ SW edge of solid
Egline SB lane of CTH G North Side of T
intersection @ Island Church Rd.
