New Topographic Data, Independent QA/QC Report Waushara County, WI November 2018

Federal Emergency Management Agency, Region V Department of Homeland Security 536 South Clark Street Chicago, IL 60605

FEMA TASK Number	HSFE05-17-J-0005
Project Name	55137 Waushara County Wisconsin FEMA 2017
Project Type	FEMA NFIP New Acquisition Terrain Data to be contributed
	to USGS 3DEP
USGS 3DEP Quality Level	2
Required Point Spacing	0.71 meters
Required Point Density	2 pulses per square meter
Required NVA Swath	<= 10 cm RMSE and <=19.6 cm 95-percent confidence level
Required NVA Bare Earth	<= 10 cm RMSE and <=19.6 cm 95-percent confidence level
Required VVA Bare Earth	<= 29.4 at 95 th Percentile
Project Location	Waushara County, Wisconsin
Project Area	647 square miles (1676 square kilometers)
Point Data Cloud Collected	November 7, 2017 through November 8, 2017
LAS Version	1.4
Point Format	6
Field Survey	Compass-Data, Inc
Point Cloud Acquisition	Kucera International Inc.
Point Cloud Post Processing	Continental Mapping Consultants, Inc.
Independent QA/QC	STARR II
Licensing	Public Domain

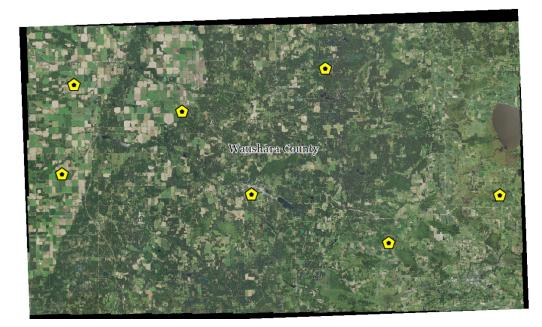
Terrasolid's LP360 Planar Statistics point cloud task was utilized to evaluate best-fitting of laser points to a plane within each flight. It computes the quality of fit values, which are stored as attributes in a shapefile. This shapfile was then loaded into LP360 using single returns only. The results are then written into the shapefile in terms of standard deviation from the plane into the StdDev field. Lesser standard deviation means the points are more tightly clustered about the plane. Instead of large flat impervious surfaces open agriculture fields where then utilized due to the lack of large development.

Figure 6. Intraswath (Smooth surface) test areas.

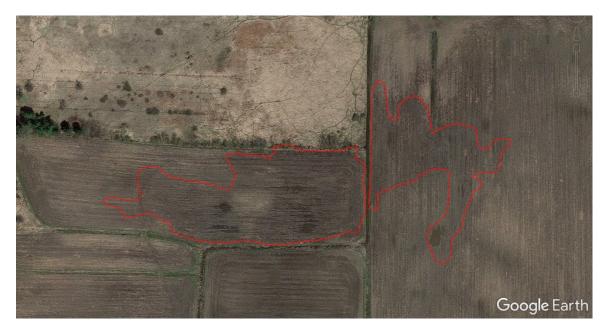
The void examples shown in Figure 10 and 11 are agriculture fields that accumulate a lot of surface drainage from surrounding areas. The soil is dark and saturated which resulted in low point density.

Figure 10. Agricultural field in a low lying area with saturated soil.

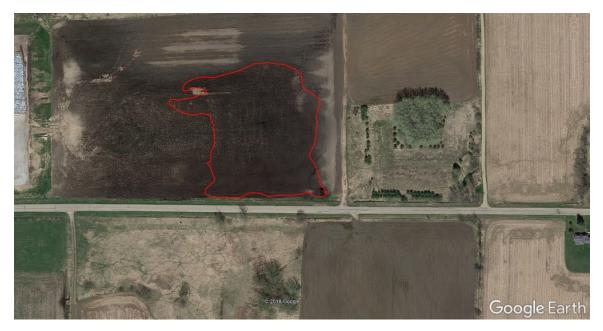
Figure 11. Agriculture field with dark saturated soil.

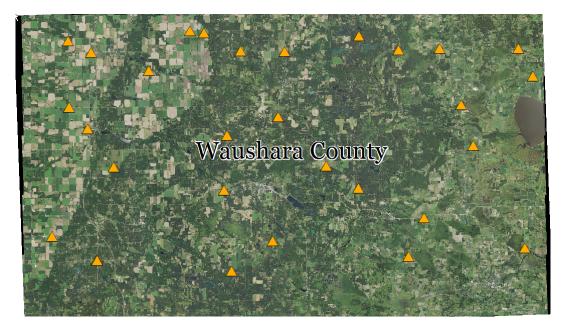
Figure 17. Vegetated Vertical Accuracy Checkpoint Distribution

The vegetated checkpoints for the VVA (vegetated vertical accuracy) assessment are collected in tall grass, brush, and forested land cover. Testing vegetated locations against the bare earth surface also validate the post processing and must meet USGS QL2 requirements for VVA at the 95th percentile (<= 29.4 cm). Meeting the QL2 requirements for both assessments validate the surface consistency and reliability of elevation values.
