SOUTHEASTERN WISCONSIN REGIONAL PLANNING COMMISSION

MEMORANDUM

SUBJECT: SOUTHEAST WISCONSIN 2015 LIDAR (SEWI_5)

Washington County LiDAR Review

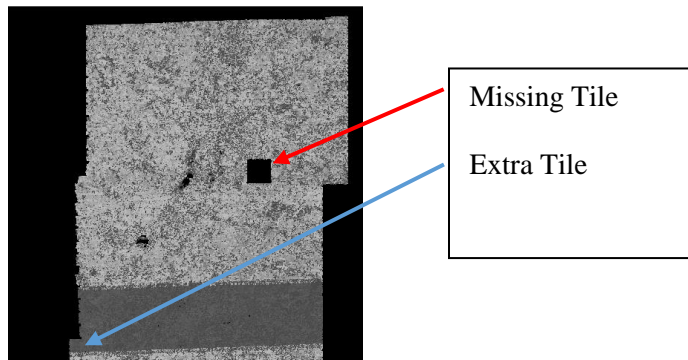
3. Classified LAS Files Review
 - Missing Tile “Id15_BE_2485_505.las”
 - Included an extra tile “Id15_BE_2414_435.las” – not required for Washington County

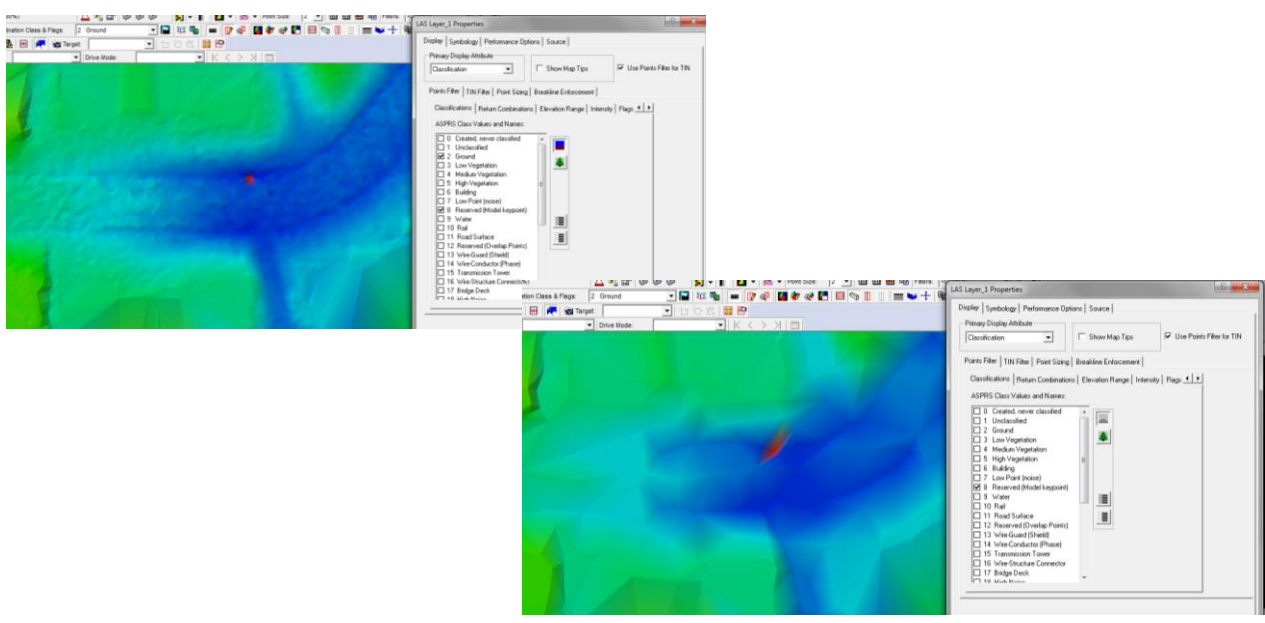
XY Location:
 Northing: 487400
 Easting: 2426200
 2 Issues: Hydro breakline encroaches into the water body significantly. Also, the elevation of the breakline is approximately 1.5 feet lower than the classified water points.
 Breakline: 956.000 feet
 Water Elev. approximately 957.5 feet

- Additional comments that require no action at this time:
 - Appears that Line Strings were used to generate the contours. Suggest using soft line strings in the contouring option to make easier transitions and less hard turns in the contouring process. Understand that the file sizes would slightly increase.
 - Model Keypoints – Points were generated but concerned that the points were generated based on a 2ft contour option instead of a 1ft. It appears that the Contour Keypoint algorithm was utilized with the settings of 2ft and 20ft which might be too general based on the screen capture below. Might look to reset contours keypoints to a 1ft option and possible 10ft to better characterize the topography with a greater accuracy.

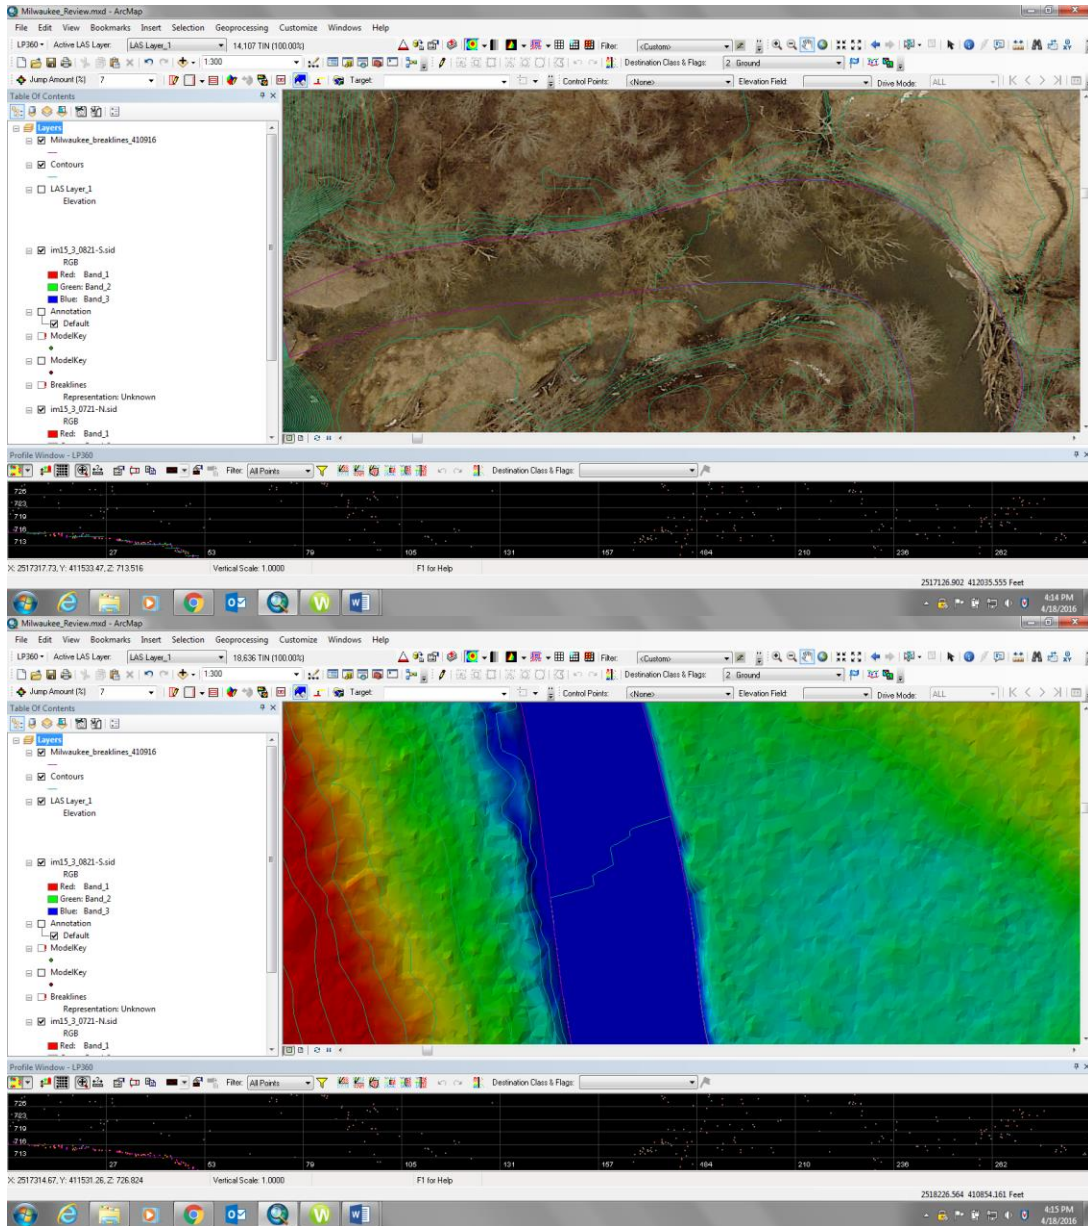
Milwaukee County – NAD27 / NGVD29

Points outside of breakline. Shoreline has points cleared but the breakwater wall did not have any points cleared away from breakline.
